ARBORIST REPORT

DVP Hotel Development LP

175 Wynford Drive

August 2020

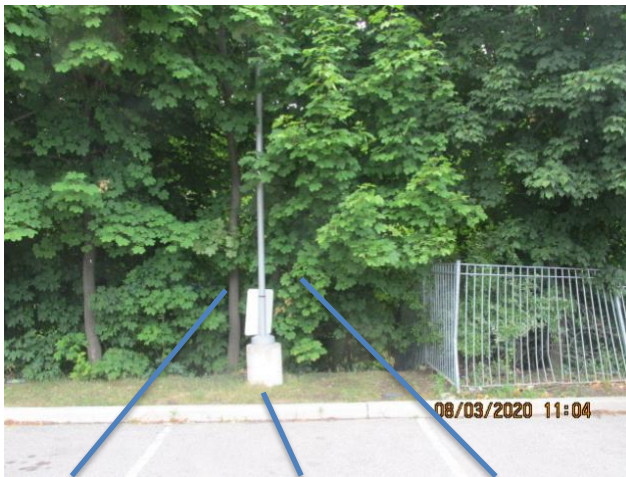
Tree 35 is a two-stemmed (7.5 and 17.5cm DBH) Norway maple tree located within 1m of the adjoining property line and the proposed construction at the site. The tree will not survive the construction both because the close proximity to the construction limit and the fact that the tree possesses a “poor” health condition rating. As such it is recommended that communication with Delmanor be undertaken and a tree replacement initiative be planned.

Tree 34 Property corner with tree 35 behind and adjacent tree 34

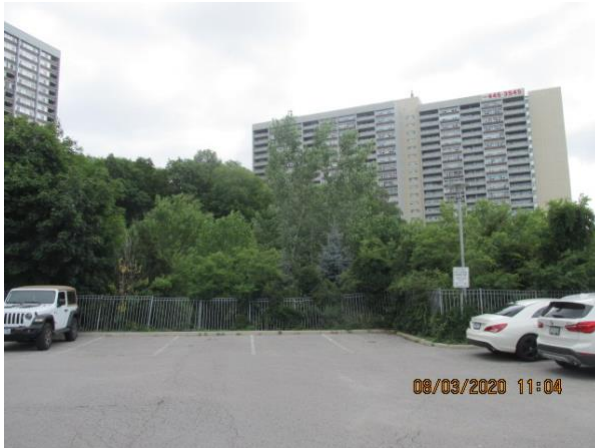
Trees 1, 2, and 33 are 3 Norway maple trees that are positioned close to the property line and will be “injured” to some degree by the development at the subject site. Considering these 3 trees are categorized as invasive tree species, it is recommended that they be removed and replaced with an appropriate ravine tree species. However since ownership of these trees are with the neighbouring property owner, and if the trees remain, care must be taken in preserving the trees during the construction period. As such during the first phase of excavation and after the installation of the tree protection fencing, special arboricultural measures are to take place.

Neighbouring ravine trees 1-8 & 26-33 in upper area, above the high circular concrete retaining wall

2. The project Arborist should monitor the excavation and advise on the amount of root pruning needed.
3. Project Arborist should be on-site to monitor demolition of the existing dwelling foundation in areas where the foundation falls within the minimum TPZ.

6. Water the soil-root profile to maintain soil moisture.
7. Where there is a need to provide ground protection within the TPZ the inclusion of Horizontal Tree Protection (HTP) may be necessary. The details of HTP are added in the Appendix of this report for reference. Should Urban Forestry require HTP the detail showing wood chips in Appendix B will be implemented.

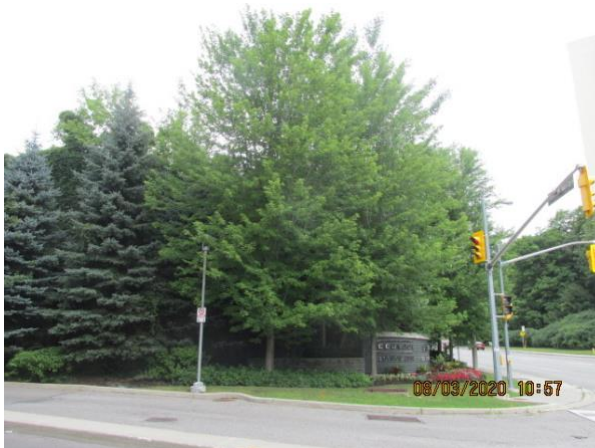
On the Tree Inventory & Protection Plan one will see that the TPZ limits for some trees overlap the subject site and as such assume “injured” to the tree roots. However due to the location of the trees and the fact that there can be no root extension beyond the retaining wall and foundation, some portions set well inside the abutting property, it is my opinion that “injury” to these trees relating to the construction works at the subject site will not occur and should not be considered. A review of the survey indicates that the retaining wall ranges in height is approximately 7m tall.

Neighbouring ravine trees 9-25 with 7m high concrete retaining wall behind trees

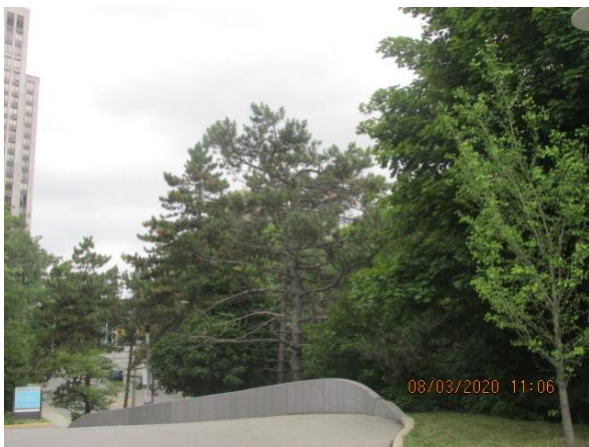
Ravine trees 78-83 down east side of entrance driveway

Trees 73, 75, 77, 79, 81, 82, and 83 are 7 Austrian pines (*Pinus nigra*) are located between the sloped entrance driveway and Wynford Drive. All 7 Austrian pines are proposed for removal due to the conflict with the new building and entrance design. Aside from removing these pines associated with the development the trees should be removed based on their declining health conditions.

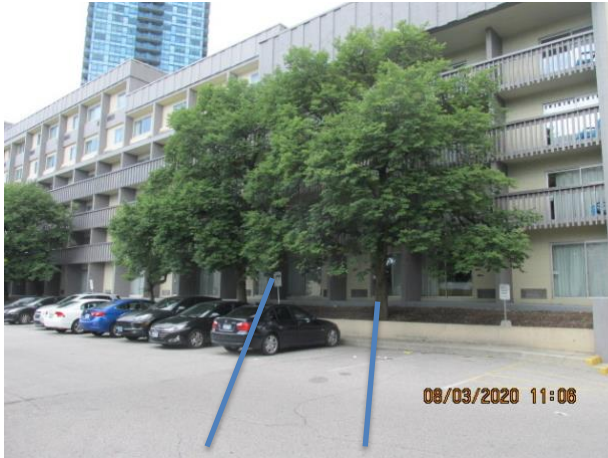
Tree 85 Tree 84

Trees 84 and 85 are 2 little leaf lindens that are located adjacent the existing hotel building possessing a health condition rating of “poor to fair”. These 2 trees are proposed for removal as they are in conflict with the associated construction of new buildings on the site.

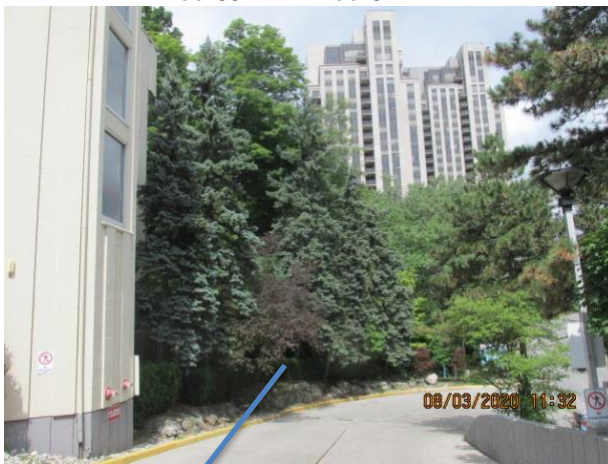
Ravine trees 87-99 on west side down entrance driveway

Trees 87, 88, 89, 95, 96, 98, and 99 are 7 Colorado blue spruce (*Picea pungens*) trees located adjacent the sloped entrance driveway. All but 1 tree possesses a “poor” to “very poor” health condition rating and are declining in overall health. It is recommended that all 7 trees be removed and replaced with appropriate tree species that are well suited for ravine areas. Though Colorado spruce is not considered an invasive tree species an opportunity to replace these unhealthy non-native trees as part of this development proposal is strongly advised.

Tree 90 is a small two-stemmed (5cm and 8.5cm DBH) smooth serviceberry and is located adjacent the sloped entrance driveway. The serviceberry possesses an “extremely poor” health condition rating and is recommended for removal based on its declining health condition.

Trees 91, 92, and 94 are 3 crabapple sp. also located adjacent the sloped entrance driveway. Similar to the serviceberry these tree are declining in health and possess a health condition rating of “poor” to “extremely poor”. These tree are recommended to be removed based on their declining health condition.

Tree 93 is sole white birch (*Betula papyrifera*) located behind (west) of the crabapple trees. The tree is in severe decline and possesses a “poor” health condition rating. It is recommended to remove the tree and replace the tree with an appropriate native tree species sited for the ravine area.

Tree 97 is a small multi-stemmed (5.5cm, 8cm, 8cm, 8cm DBH) ivory silk lilac tree positioned under (i.e. suppressed) by 2 Colorado spruce trees beside the sloped entrance driveway. The tree is in decline and presently possesses a “poor” health condition rating. It is recommended that the tree be removed and replaced with an appropriate native tree species sited for the ravine area.

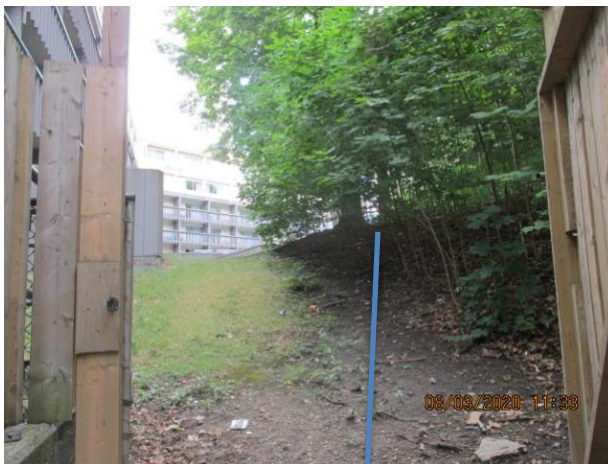
108 No tag	Beech		63	11	Fair	Fair	Fair	Straight trunk form; defined root flare; branch stub rot; small girdling root; min. crown deadwood; few broken branches; crown reach to south 7m. Retain tree with injury.
109 No tag	Sugar maple	<i>Acer saccharum</i>	63	11	Fair	Fair	Fair	Defined trunk flare; hole seen between trunk flares near ground level; virus tissue growth at 4.5m; min. crown deadwood; balanced crown form. Retain tree with injury.
110 Tag 24	Sugar maple	<i>Acer saccharum</i>	18.5	6	Fair	Poor	Poor to fair	Straight trunk form; min. crown deadwood; poor crown form.
111 Tag 23	Sugar maple	<i>Acer saccharum</i>	10, 12.5	7	Poor	Poor	Poor	Suppressed tree; poor crown form – asymmetrical crown form.
112 Tag 15	Basswood	<i>Tilia americana</i>	56	14	Poor to fair	Poor	Poor	Trunk with small stems (15cm diameter) from base cut at approx. 2m with epicormic shoots from stems; crown overlapping pool; crooked trunk form; trunk lean with majority of crown over pool; poor crown form. Retain tree with injury.

North side of hotel facing west from gate between building and tree 108
Note the advanced sugar maple regeneration

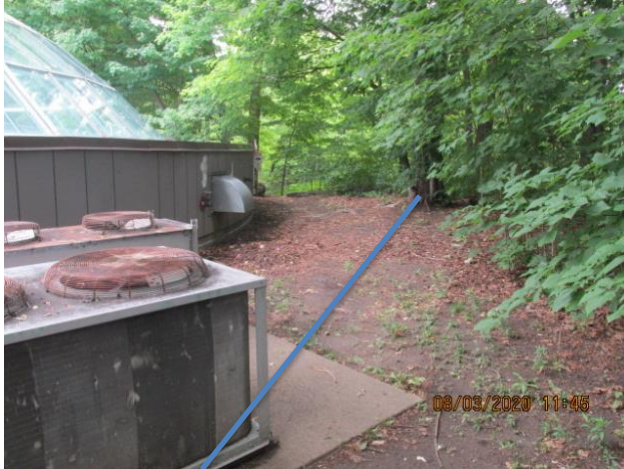
Trees 112, 113, 114 adjacent indoor pool structure

Trees 109 (sugar maple), 112 (basswood), 114 and 120 (sugar maple) are trees affected by the demolition of the existing indoor pool structure and foundation. Tree 108 (American beech) is impacted to a minimal degree by the removal of the existing vent structure.

113 Tag 14	Sugar maple	<i>Acer saccharum</i>	11	5	Fair	Fair	Fair	Crown reaches pool structure; partially suppressed tree; poor crown form.
114 No tag	Sugar maple	<i>Acer saccharum</i>	42	8	Fair	Fair	Fair	Straight trunk form; crown reaches pool. Retain tree with injury.
115 Tag 22	Sugar maple	<i>Acer saccharum</i>	23	7	Good	Fair	Fair to good	Trunk with no major defects; thinning crown top.
116 Tag 17	Sugar maple	<i>Acer saccharum</i>	51.5	9	Fair	Fair	Fair	Straight trunk form; crown reaches pool overlap by 1m; min. crown deadwood present; asymmetrical crown form.
117 Tag 18	Sugar maple	<i>Acer saccharum</i>	20.5	6	Poor	Poor	Poor	Very poor trunk form, raps around trunk of tree 116; min. crown deadwood.
118 Tag 20	Sugar maple	<i>Acer saccharum</i>	29	8	Fair	Fair	Fair	Straight trunk form; crown with generally good form.
119 Tag 21	White pine	<i>Pinus strobus</i>	56	6	Poor	Poor	Poor	Straight trunk form; defined root flare; very little live crown volume; abundant branch mortality; many broken branches.

1. The Project Arborist is to be on-site to monitor demolition of the existing outdoor pool structure.
2. Removal of the concrete foundation, by an excavator, will be carried out with care and the concrete foundation closest to the trees pulled away from the existing soil-root profile area.

4. Any exposed soil-root profile is to be covered immediately with topsoil to prevent root desiccation.
5. Watering of the soil-root profile and area at least once per week, or as specifically instructed by the Arborist, is recommended to maintain soil moisture.

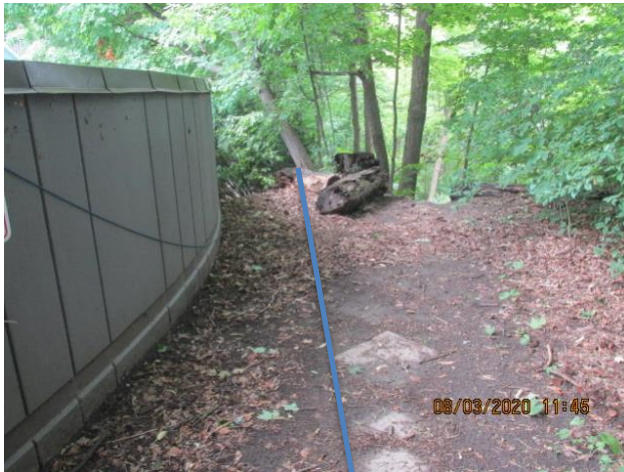
Indoor pool structure & Tree 120

120	Sugar maple	<i>Acer saccharum</i>	34	6	Poor	Poor	Poor	Trunk lean to SE; exposed root collar and trunk flare; very poor crown form; irregular crown form; girdling root. Retain tree with injury.
121	Sugar maple	<i>Acer saccharum</i>	9	3	Poor	Poor	Poor	Suppressed tree; rot site at branch stub at 1.5m; poor crown form.
122	Sugar maple	<i>Acer saccharum</i>	37, 60	13	Fair	Poor	Poor to fair	Two-stemmed tree from base; diverging stems; south stem overlapping pool; thinning crown; some crown deadwood; broken branches on south side; trunk white face scar on south stem.
123	Sugar maple	<i>Acer saccharum</i>	12.5	4	Fair	Fair	Fair	Suppressed tree; balanced crown form. Retain tree with injury.
124	Sugar maple	<i>Acer saccharum</i>	15	4	Fair	Fair	Fair	Suppressed tree; balanced crown form; dead branch stub present. Retain tree with injury.
125	Sugar maple	<i>Acer saccharum</i>	8.5, 16.5	7	Fair	Fair	Fair	Trunk with no major defects; normal crown form. Retain tree with injury.

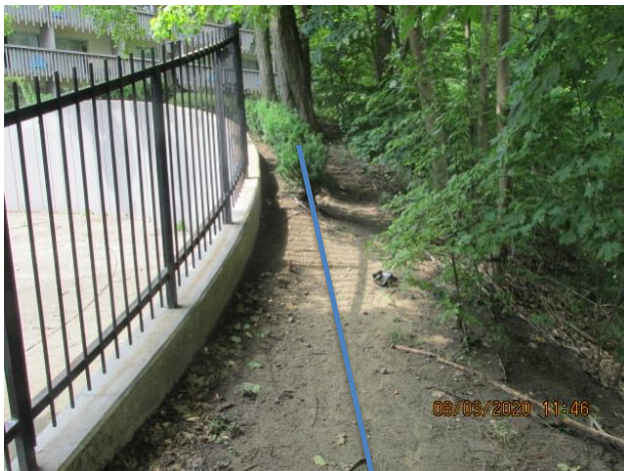
Outdoor patio & Trees 126, 127, & 128

126	Sugar maple	<i>Acer saccharum</i>	29	6	Very poor	Very poor	Very poor	Very poor crown form competing with tree 127; irregular crown form; crown overlapping pool; rot at branch stub at 3m. Retain tree with injury.
127	Sugar maple	<i>Acer saccharum</i>	65	10	Fair	Fair	Fair	Trunk with no major defects; trunk splits at 6m with possible <i>included bark</i> formation; some crown deadwood. Retain tree with injury.

128	Sugar maple	<i>Acer saccharum</i>	22.5	6	Poor	Poor	Poor	Suppressed tree with very poor crown form; crown with rot sites. Retain tree with injury.
129	Sugar maple	<i>Acer saccharum</i>	45	9	Very poor	Very poor	Very poor	Trunk lean to west; poor crown form; min. crown deadwood; vertical trunk rot up to 3m.
130	Ironwood	<i>Ostrya virginiana</i>	10, 13, 21.5	10	Fair	Poor	Poor to fair	Diverging trunk stems; largest stem facing ravine; poor crown form; crown deadwood present.
131	Sugar maple	<i>Acer saccharum</i>	50	13	Fair	Fair	Fair	Tree located on elevated landscape area; exposed roots and trunk flare; straight trunk form; slight trunk lean to south; some root collar rot. Retain tree with injury.
132	Choke cherry	<i>Prunus virginiana</i> L. var. <i>virginiana</i>	10	3	Fair	Fair	Poor	Small ornamental tree. Remove tree – poor condition.
133	Choke cherry	<i>Prunus virginiana</i> L. var. <i>virginiana</i>	3, 4, 4	3	Poor	Poor	Poor	Small ornamental tree with poor crown characteristics. Remove tree – poor condition.

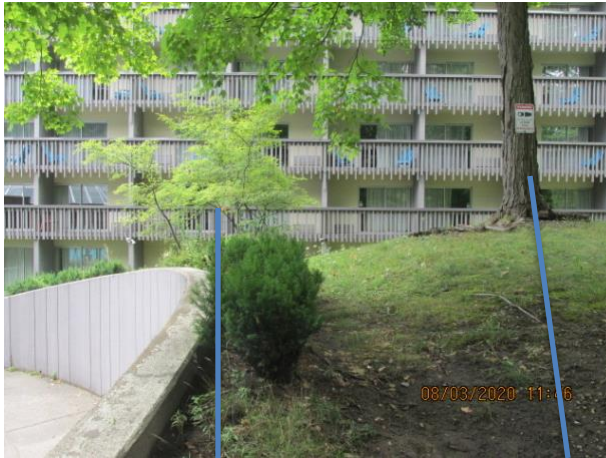
Small serviceberries tree 132 & 133 Tree 131

Trees 132 and 133 are 2 smooth serviceberries are located close to the hotel, south of tree 131, and is proposed for removal. The 2 small ornamental sized trees possess a “poor” health condition rating. Due to the location of the trees and their declining health it is recommended to remove the trees and replace them with an appropriate ravine species.

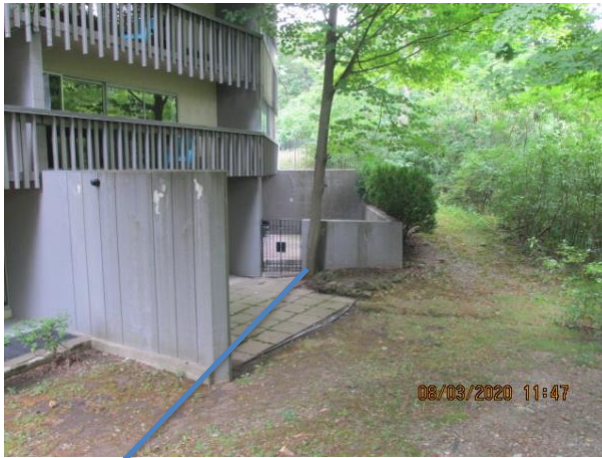
Tree 137 is a sugar maple tree in a restricted growing habitat and abuts a concrete patio foundation and extremely closed to the hotel building itself. The health condition rating is “very poor” with poor crown characteristics partly due to past pruning operations. Due to the declining tree health and with the demolition of the patio area some supporting tree roots are anticipated to be exposed the tree is recommended to be removed.

Tree 137 located in a very restricted environment

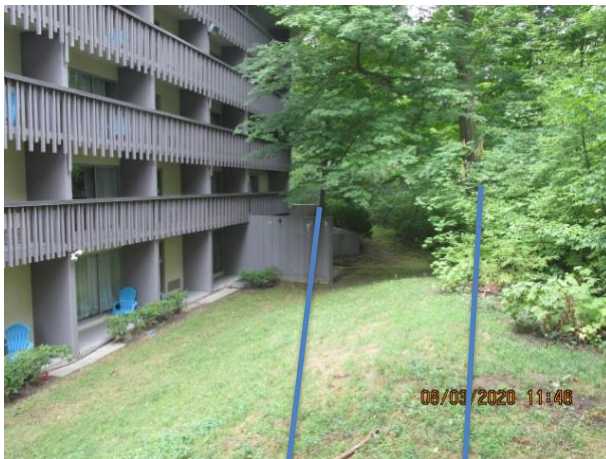
Tree 137 Tree 136

134	Sugar maple	<i>Acer saccharum</i>	26.5	8	Fair	Fair	Fair	Straight trunk form; balanced crown form.
135	Silver maple	<i>Acer saccharinum</i>	22.5	7	Poor	Poor	Poor	Crooked trunk form; poor crown form; thinning crown condition.
136	Sugar maple	<i>Acer saccharum</i>	73	14	Fair	Fair	Fair	Girdling root present; defined root flare; generally balanced crown form; trunk lean to SW; crown reaches building. Retain tree with injury.
137	Sugar maple	<i>Acer saccharum</i>	33	8	Very poor	Very poor	Very poor	Trunk located in restricted habitat, adjacent concrete patio foundation and immediately beside building; poor crown form – asymmetrical form. Remove tree – conflict with demolition work + very poor health.

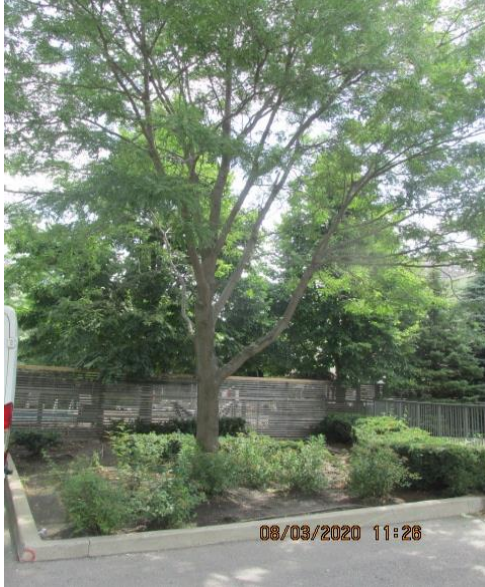
Neighbouring Tree 142

A sole regulated sized tree identified as a little leaf linden tree 142 is located on the neighbouring property close to the outdoor pool area. The tree is 31cm DBH and possesses a “fair” health condition rating. The tree is positioned well away from the property line and the general construction fencing for the project will serve as tree protection for all phases of construction.

Tree No.	Tree Species	Latin Name	DBH (cm.)	Crown Diameter (m.)	Trunk Integrity	Crown Vigour & Structure	Plant Condition (Health & Structure Conditions)	Observations & Comments
142	Thornless honey locust	<i>Gleditsia triacanthos</i>	31	11	Fair	Fair	Fair	Tree located in landscape area – other trees removed that were in the same defined landscape area; balanced crown form; girdling root present; trunk with no major visible defects; crown pruned.

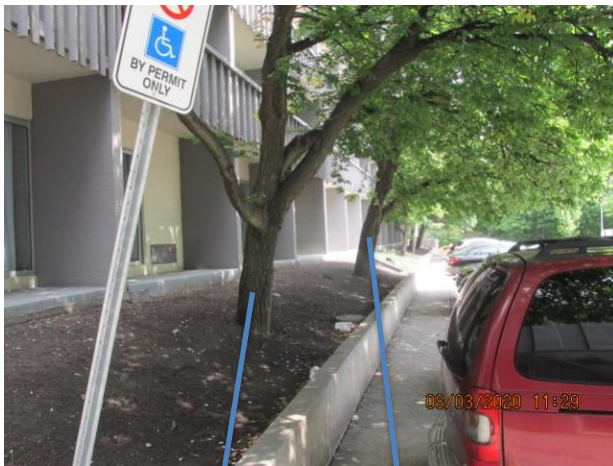
Tree 140

Tree No.	Tree Species	Latin Name	DBH (cm.)	Crown Diameter (m.)	Trunk Integrity	Crown Vigour & Structure	Plant Condition (Health & Structure Conditions)	Observations & Comments
138 Tag 923	Little leaf linden	<i>Tilia cordata</i>	25.5	6	Fair	Poor	Poor to fair	Tree located between building and concrete retaining wall; poor trunk condition – scars and rot sites; scaffold branch at 1.3m with rot site; poor crown form.
139 Tag 279	Little leaf linden	<i>Tilia cordata</i>	45	9	Poor	Poor	Poor	Tree located between building and concrete retaining wall; multi-stemmed at 1.6m trunk with lean away from building and overhanging parking spaces; poor crown form.
140 Tag 280	Little leaf linden	<i>Tilia cordata</i>	43	8	Poor	Poor	Poor	Tree located between building and concrete retaining wall; multi-stemmed at 1.5m trunk with lean away from building and overhanging parking spaces; poor crown form.
141	Little leaf linden	<i>Tilia cordata</i>	29.5	6	Good	Good	Good	Presently undersized tree and not regulated by Private Tree Bylaw; tree in outdoor pool area; normal trunk form; balanced crown form.
