SLOPE STABILITY AND EROSION RISK REPORT

175 Wynford Drive
Toronto, Ontario

Grounded Engineering Inc.

File No. 20-153

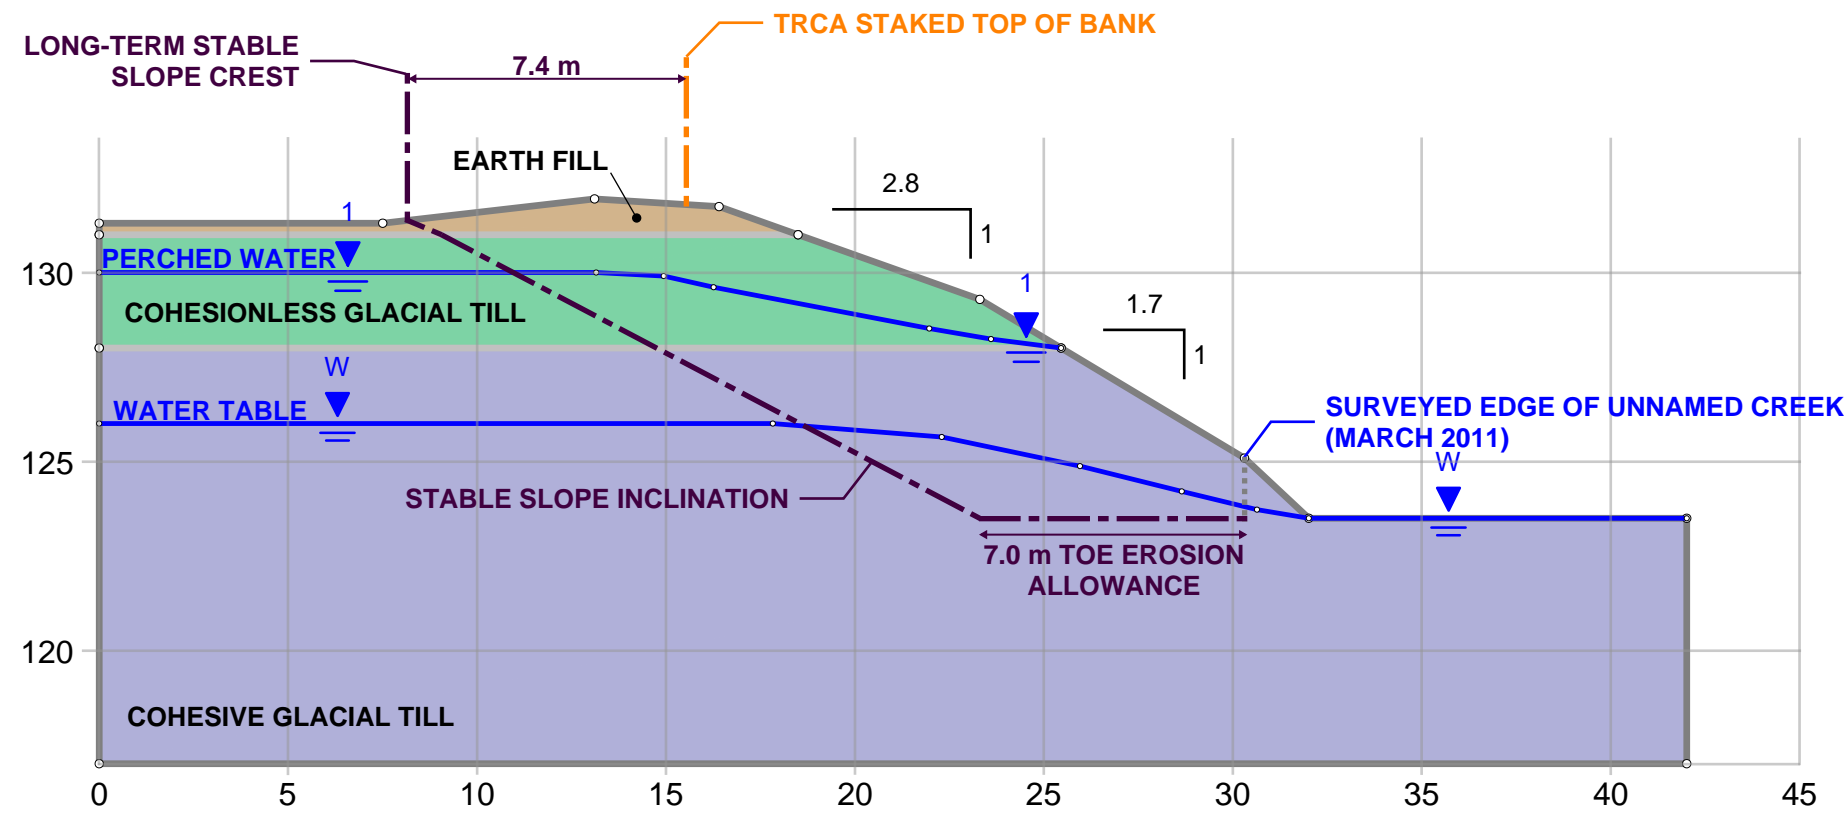
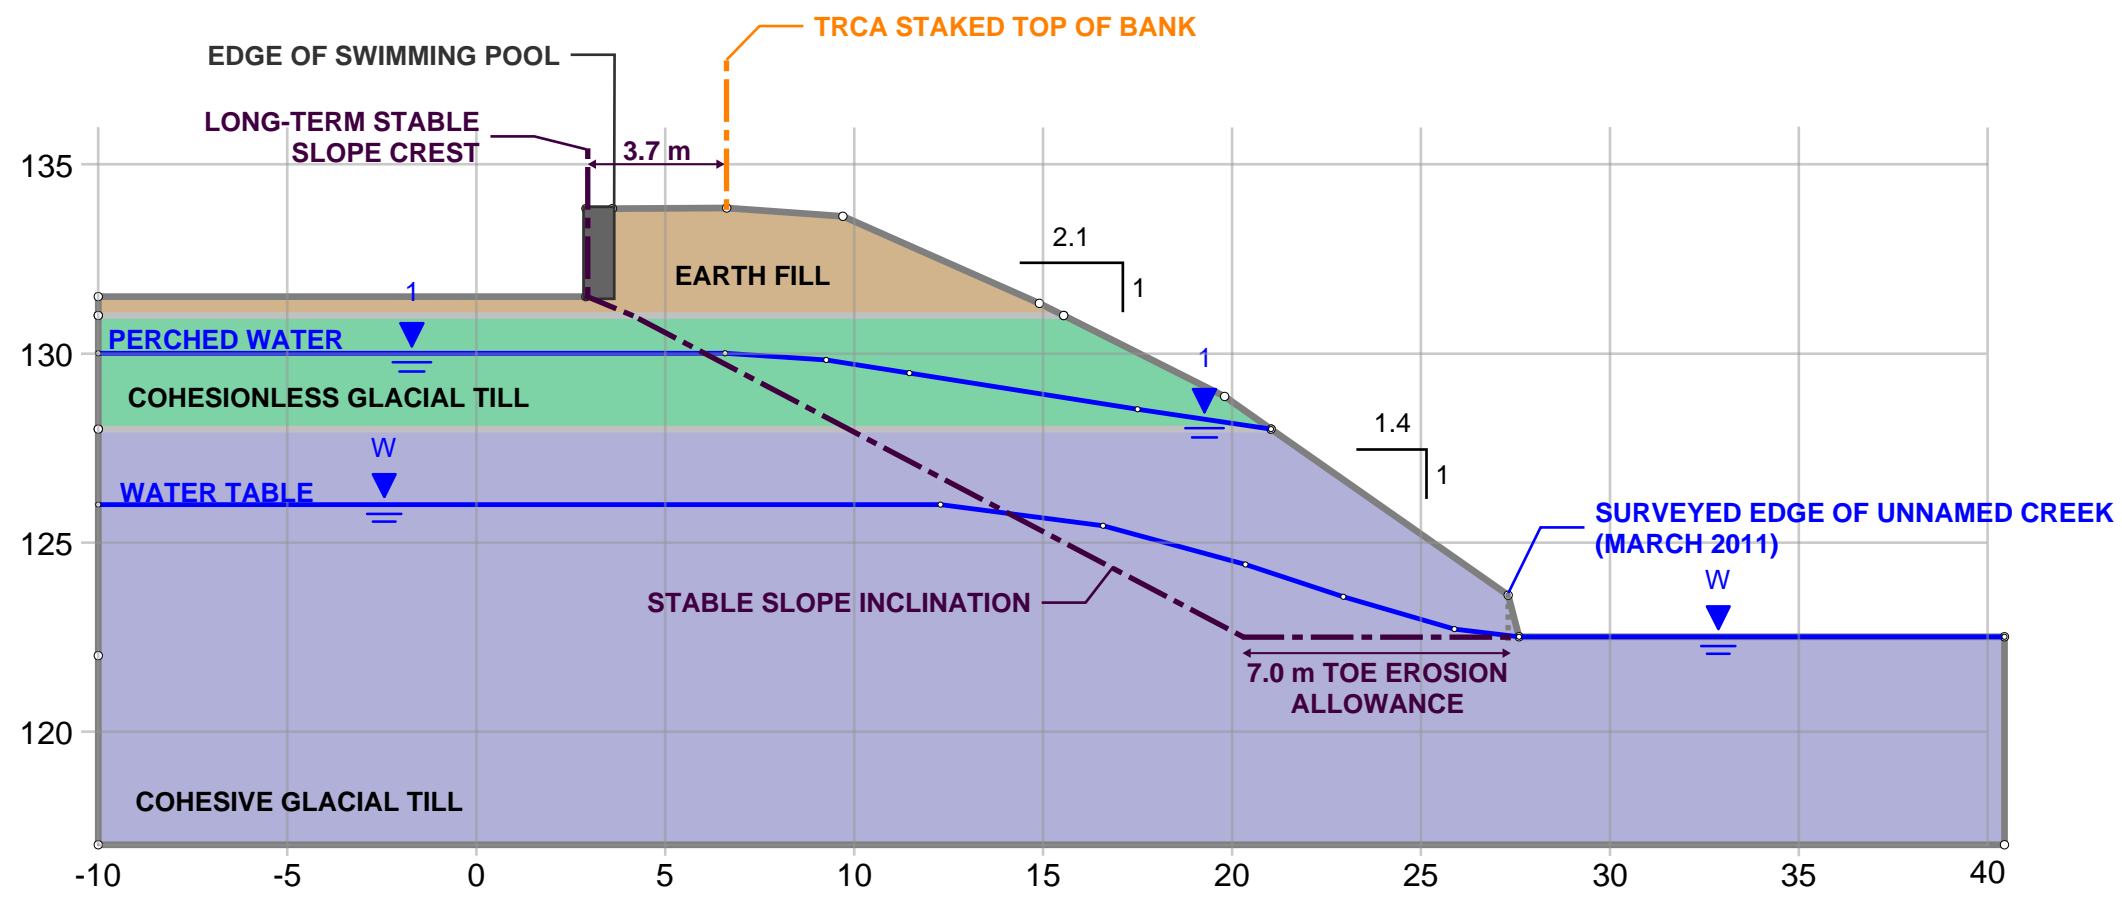
FIGURE 4A

Sections A and B have minimum factors of safety of 1.3 to 1.5. The slope at these sections are forested, no signs of erosion were observed on the slope face, with some undercut vegetation at the toe. The slope at Sections A and B are considered to be stable.

Soil Type	Stable Slope Inclinations
EARTH FILL	2.4H : 1V
NATIVE	1.9H : 1V

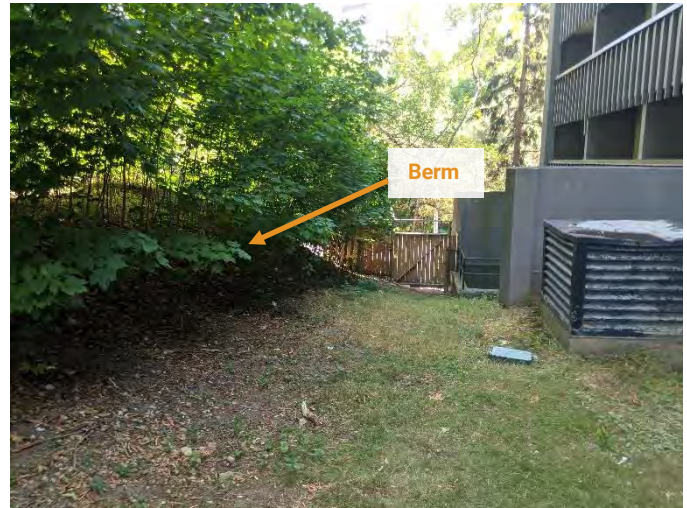
Photograph 1

Position: Tableland
Direction/Object: East
Description: The tableland is landscaped with grass. The forested berm is present north of the hotel at the slope crest.

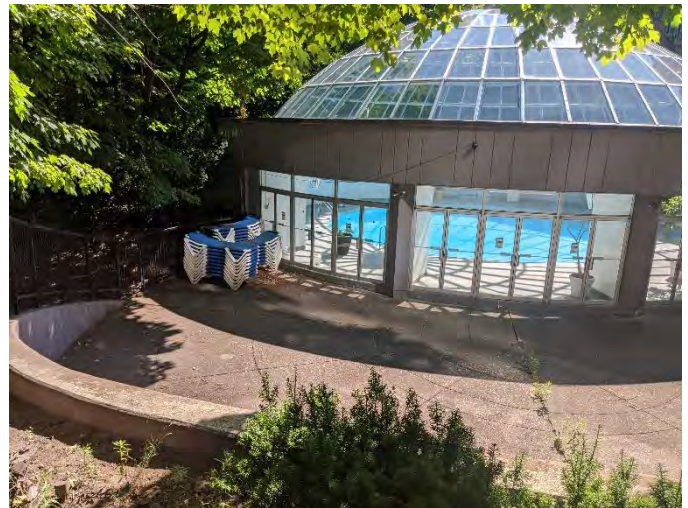
Photograph 2

Position: Pool building
Direction/Object: East
Description: The pool building is present approximately at the slope crest. There is a concrete retaining wall next to the pool.

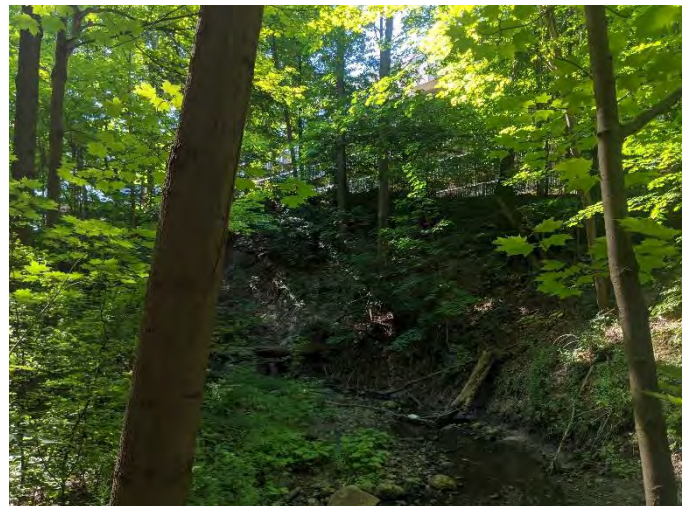
Photograph 3

Position: Within ravine
Direction/Object: South
Description: The slope is forested with mature trees and understory.

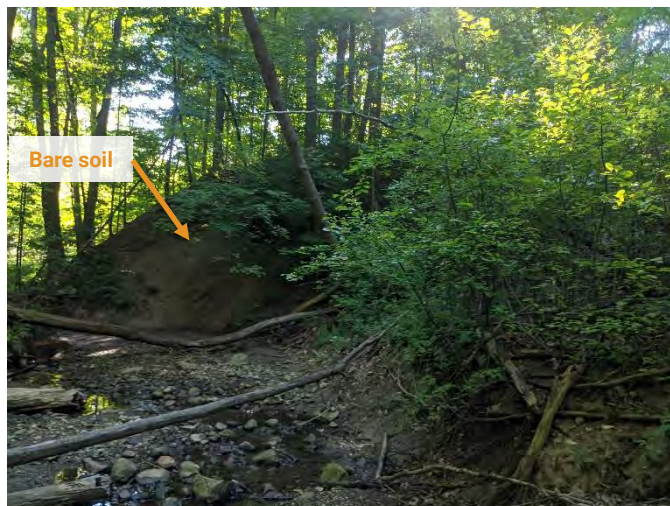
Photograph 4

Position: In the creek
Direction/Object: East
Description: There are some fallen and slightly leaning trees in the ravine. The slope face is bare and at a steep inclination, appears to be a historic failure scarp.

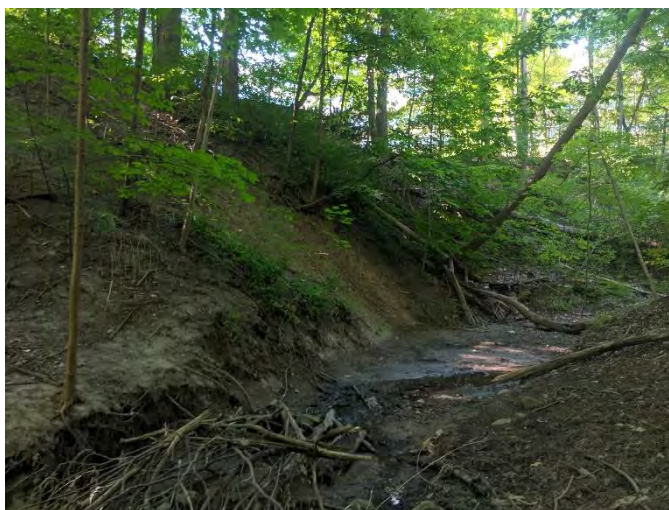
Photograph 5

Based on the toe erosion observed within the ravine, the applicable toe erosion allowance is 7 m.

Position: In the creek
Direction/Object: West
Description: Erosion is visible along the creek bank, vegetation has been undercut.

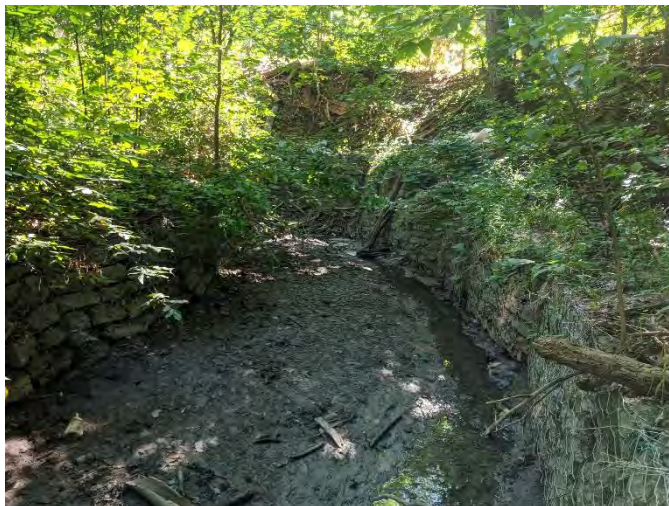
Photograph 6

Position: In the creek
Direction/Object: East
Description: There is a gabion stone retaining wall along the creek bank at the east side of the property.
