ME5276

FEBRUARY 2018

**PHASE ONE
ENVIRONMENTAL SITE ASSESSMENT
175 WYNFORD DRIVE
TORONTO, ONTARIO**

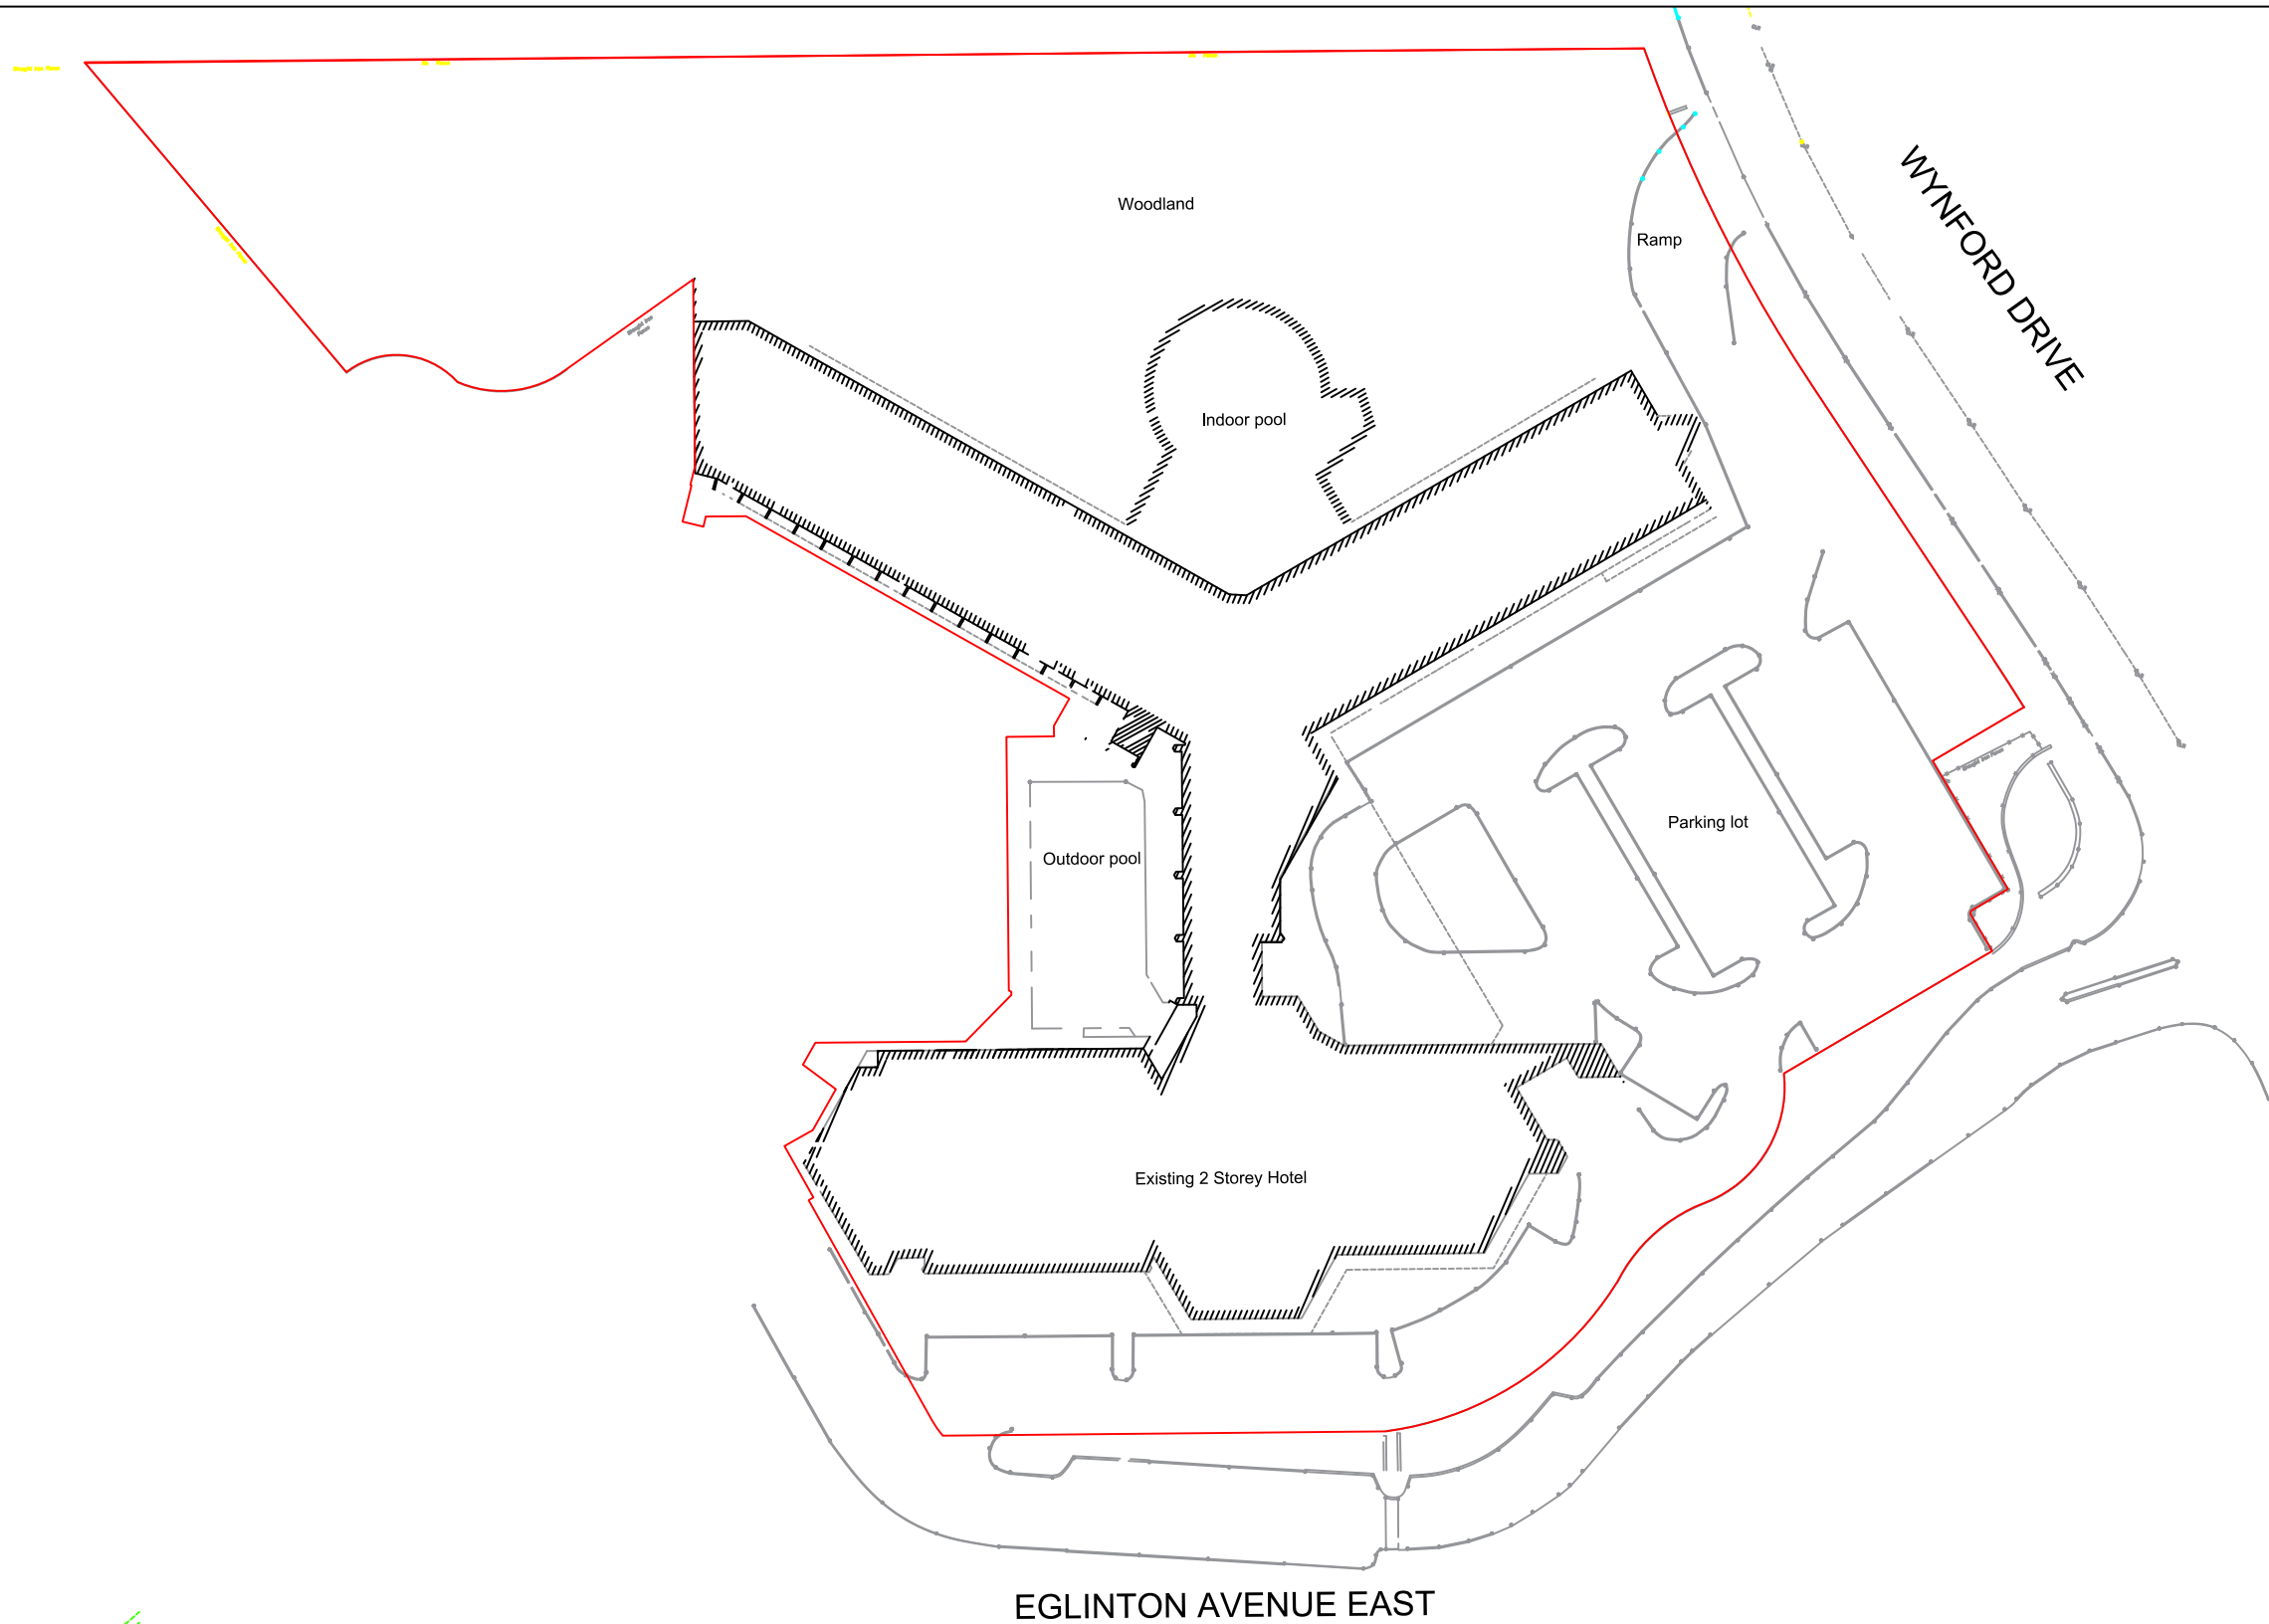
APEC	POTENTIALLY CONTAMINATING ACTIVITIES (PCA)
APEC1 - WESTERN PORTION OF SITE	IMPORTATION OF FILL MATERIAL OF UNKNOWN QUALITY (ONSITE)
APEC2 - SOUTHERN PORTION OF SITE	GASOLINE AND ASSOCIATED PRODUCTS IN TANKS
APEC3 - PARKING LOT	SALT AND DE-ICING PRODUCTS

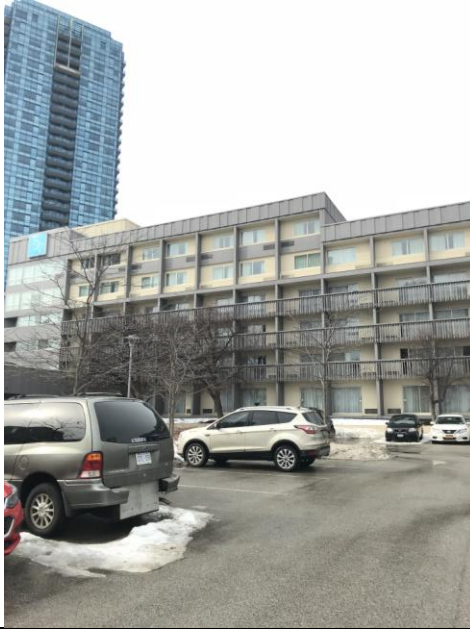
Hotel and parking lot, facing north.

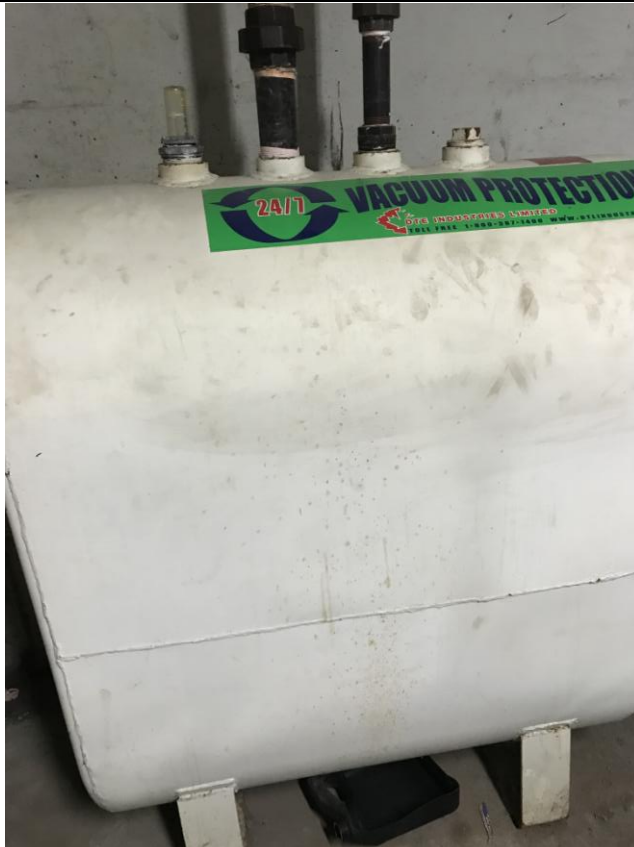
AST in southern boiler room, facing south.

- No PCAs or APECs were identified.
- An AST was identified in the southern boiler room, for diesel to operate the emergency generator, and was deemed to be in good condition.
- Two hydraulic elevators were identified.
- Off-site PCAs were not retained due to either distance or registered RSCs which indicated no significant groundwater impacts.

- No underground or aboveground storage tanks or chemical storage was known to be historically or currently present on the Site.
- An AST is present in the basement of the southern boiler room however it has not been filled for a long time due to the fill pipe missing a backflow piece.
- The building was constructed in 1968
- No spills or floods are known to have occurred on the Site.
- Mr Porter was not aware of any other potential for contamination on the Site.

The Site was inspected on February 15, 2018. Photographs were taken throughout the Site (as provided in the attached photo log) and any relevant observations were recorded. No notable features of the Site were observed with the exception of a diesel AST noted in the southern boiler room.

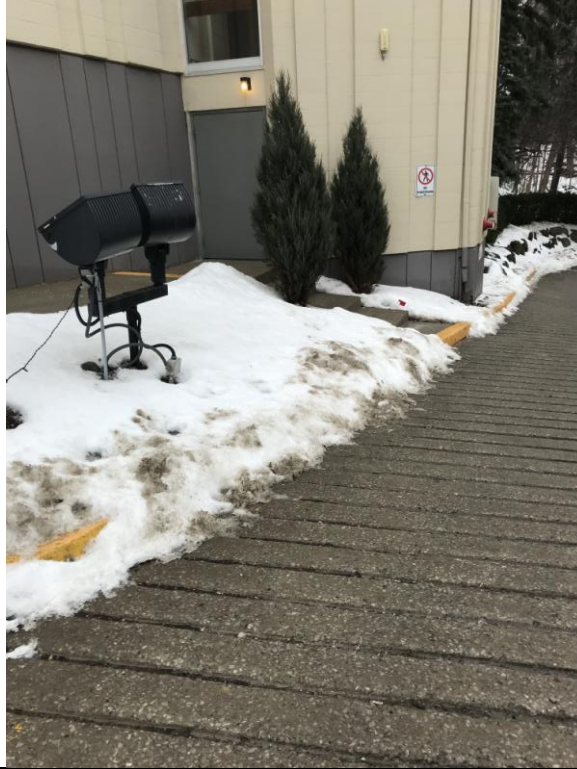
Steep ramp at eastern portion of Site, facing north.
