**NATURAL HERITAGE IMPACT STUDY**

**175 Wynford Drive  
City of Toronto**

**Project No. 2020-192**

**September 21<sup>st</sup>, 2020**

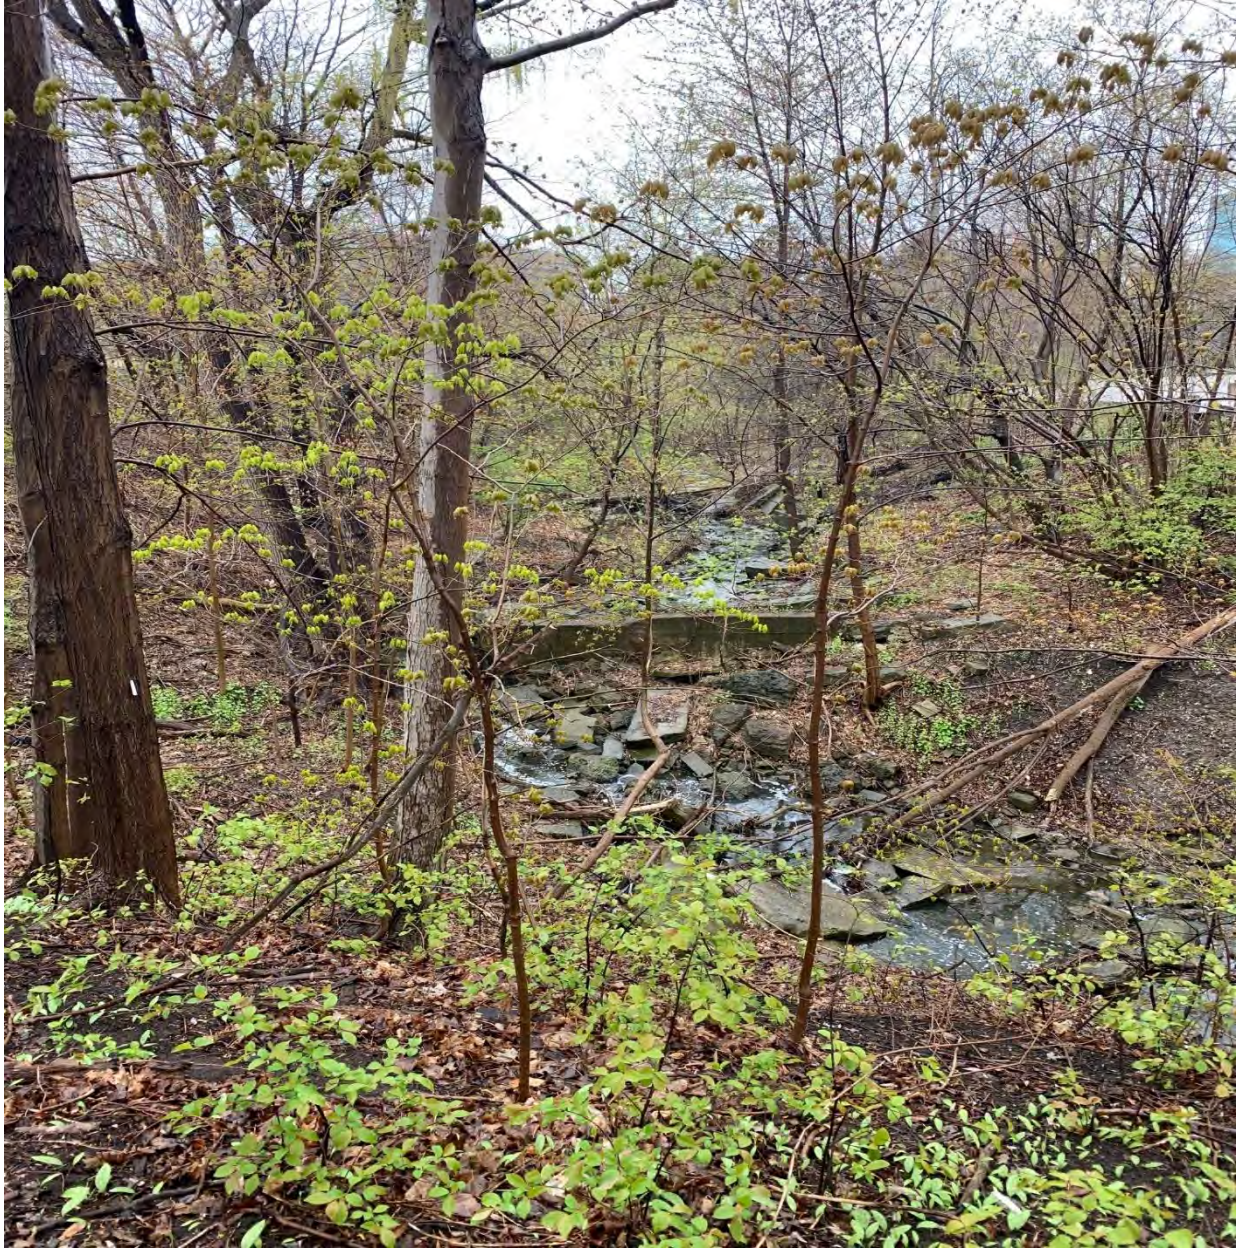
Looking northwest from Photo #7

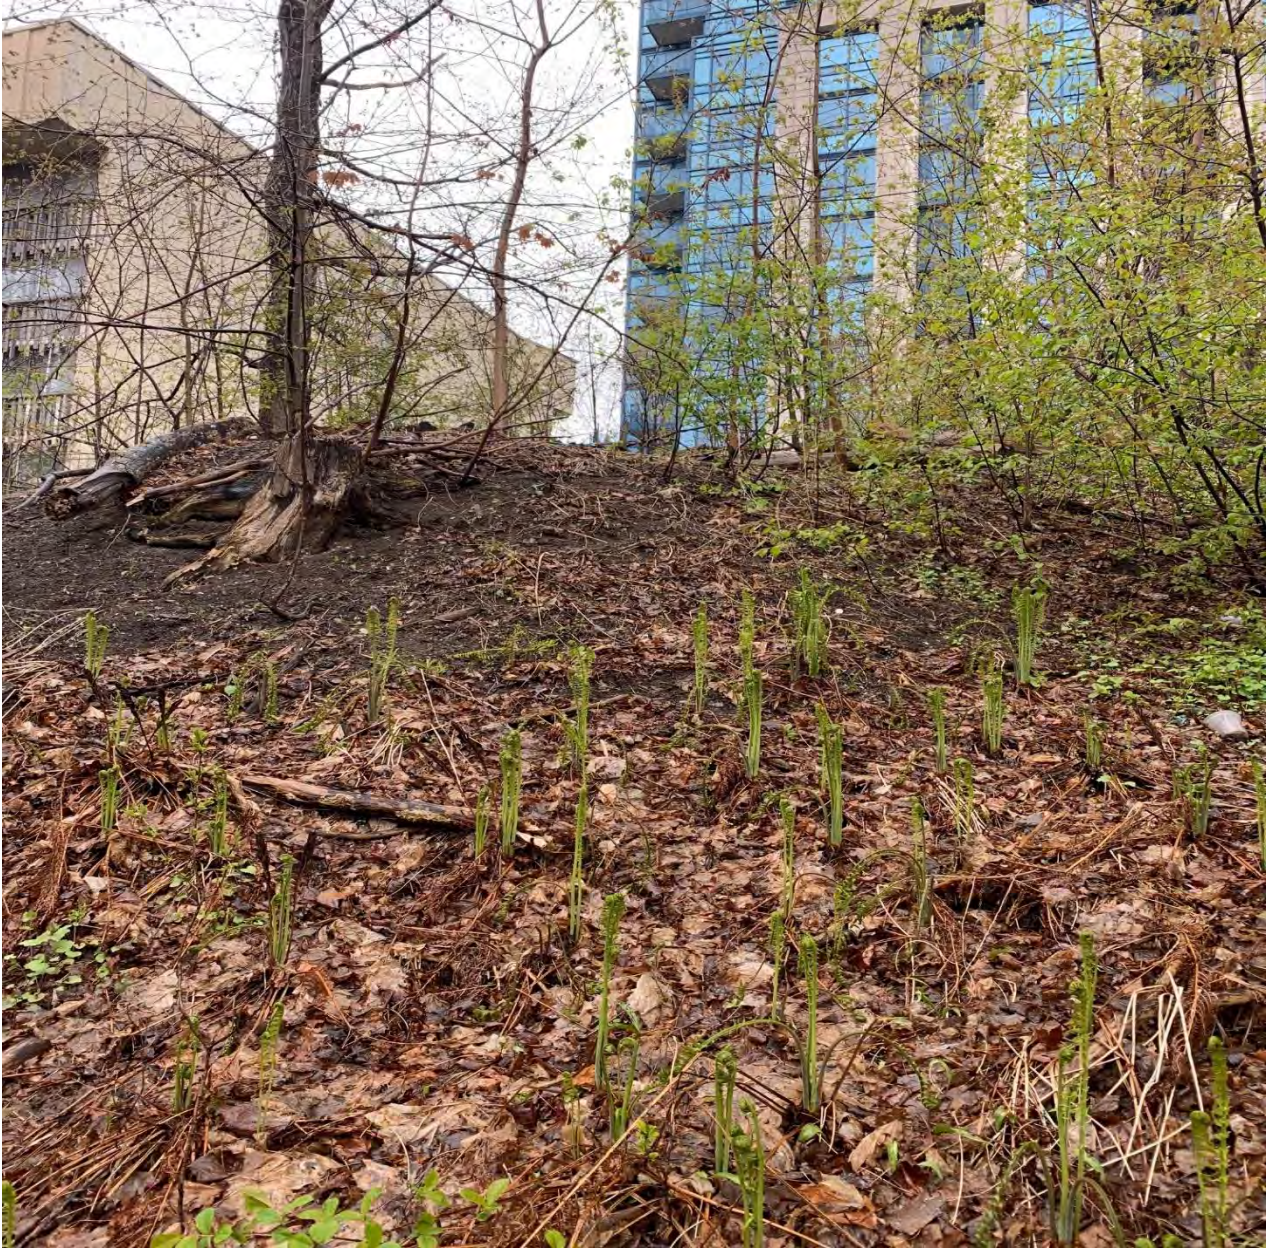
Looking upslope from Photo #8

The ravine has moderate to steeply sloping topography (Figure 3) with evidence of past and recent soil erosion along portions of the upper slope and in proximity to the tributary (bank undercutting). The tableland portion of the site (hotel/parking lot) gently slopes towards the north.

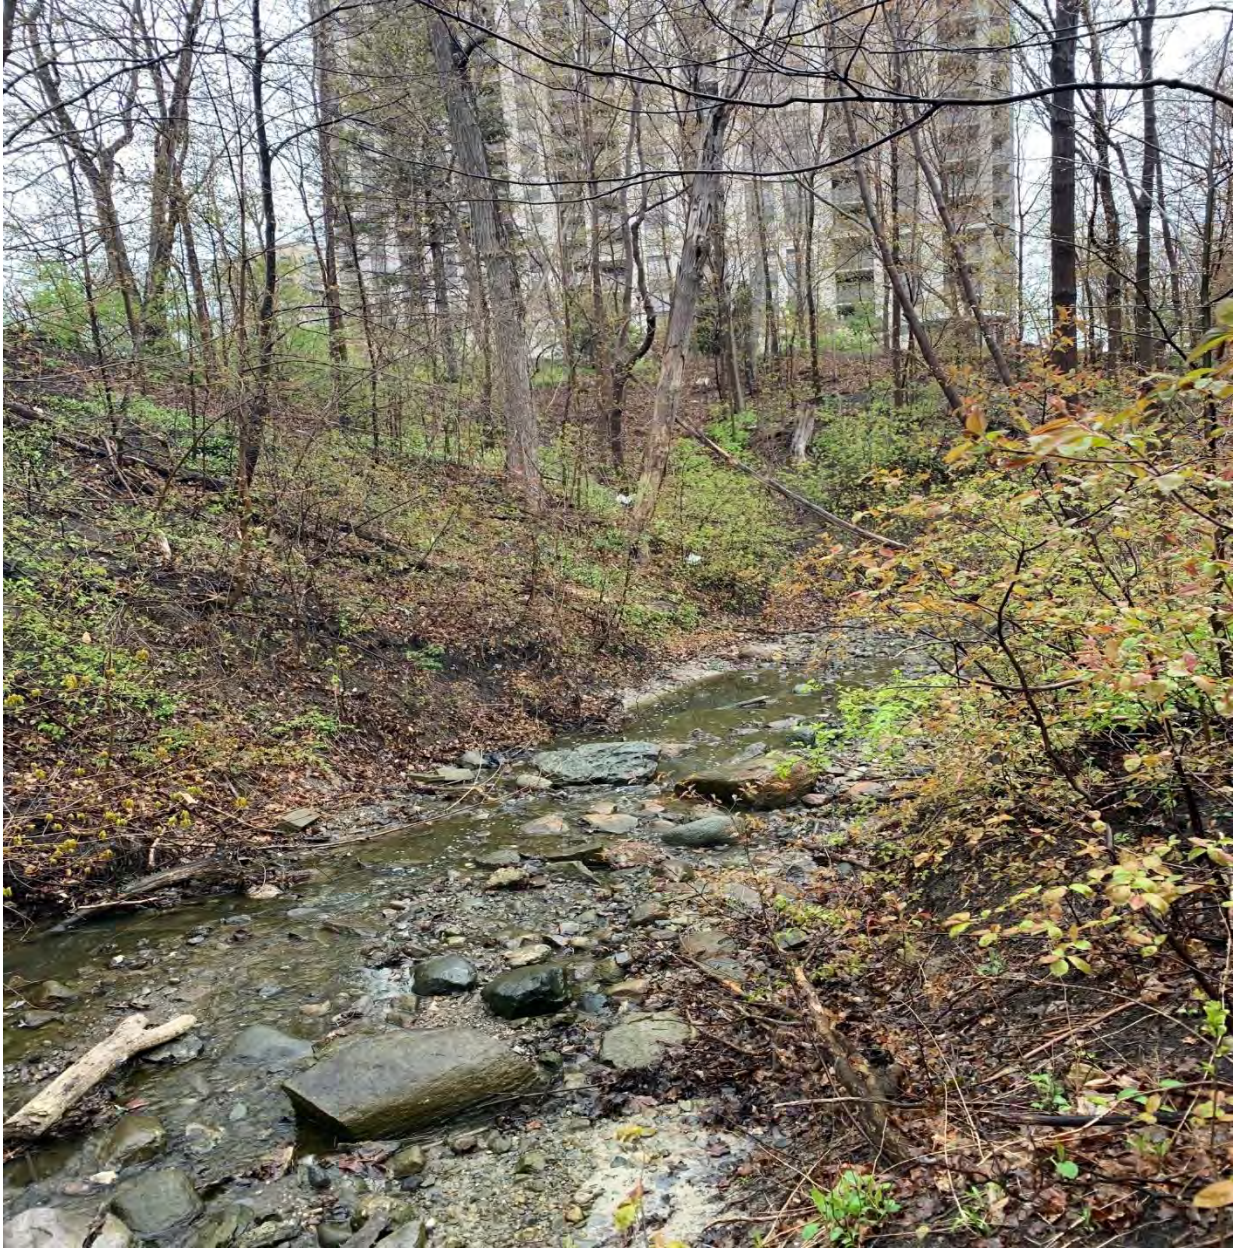
Looking downstream from Photo #8

No fish species were observed within the watercourse on the subject property. Downstream barriers and culvert obstructions at Wynford Drive appear to be limiting fish movement to and from the main channel of the East Don River. The watercourse exhibits a meandering channel form with evidence of bank undercutting and erosion.

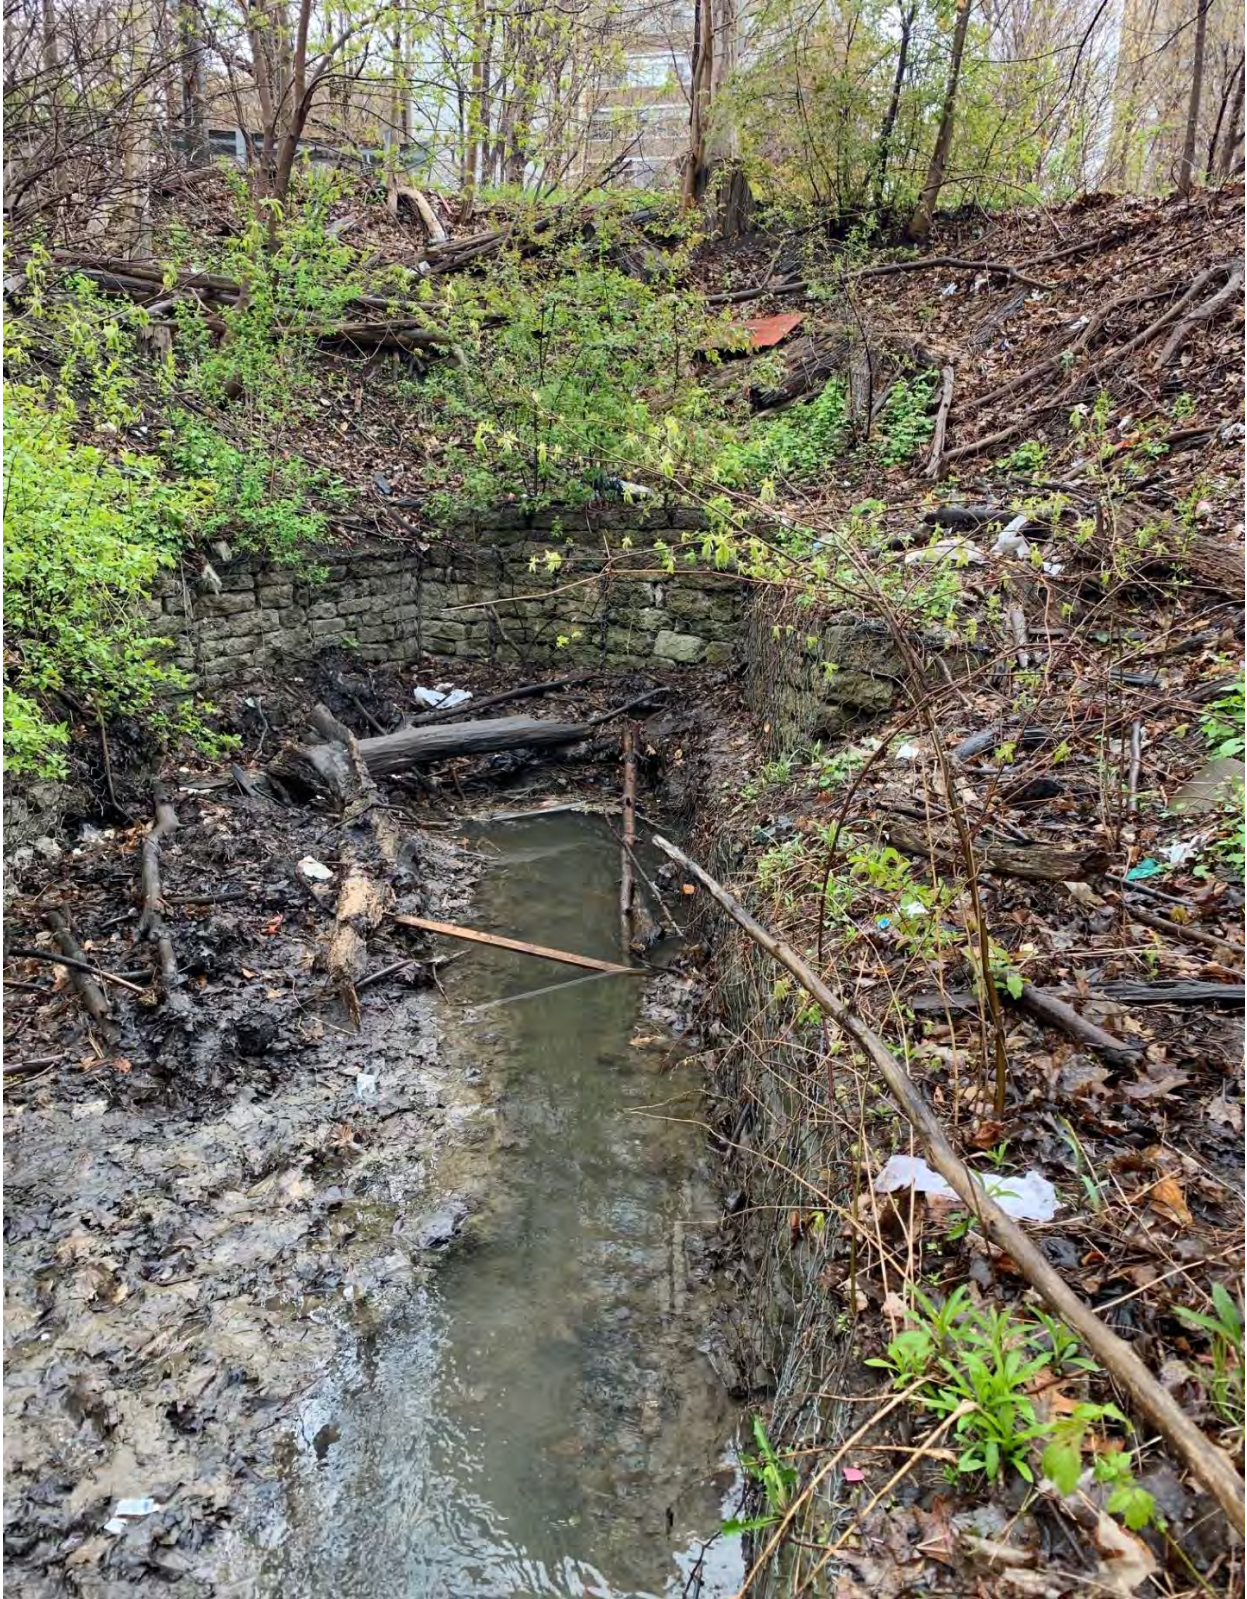
Culvert opening under Wynford Drive

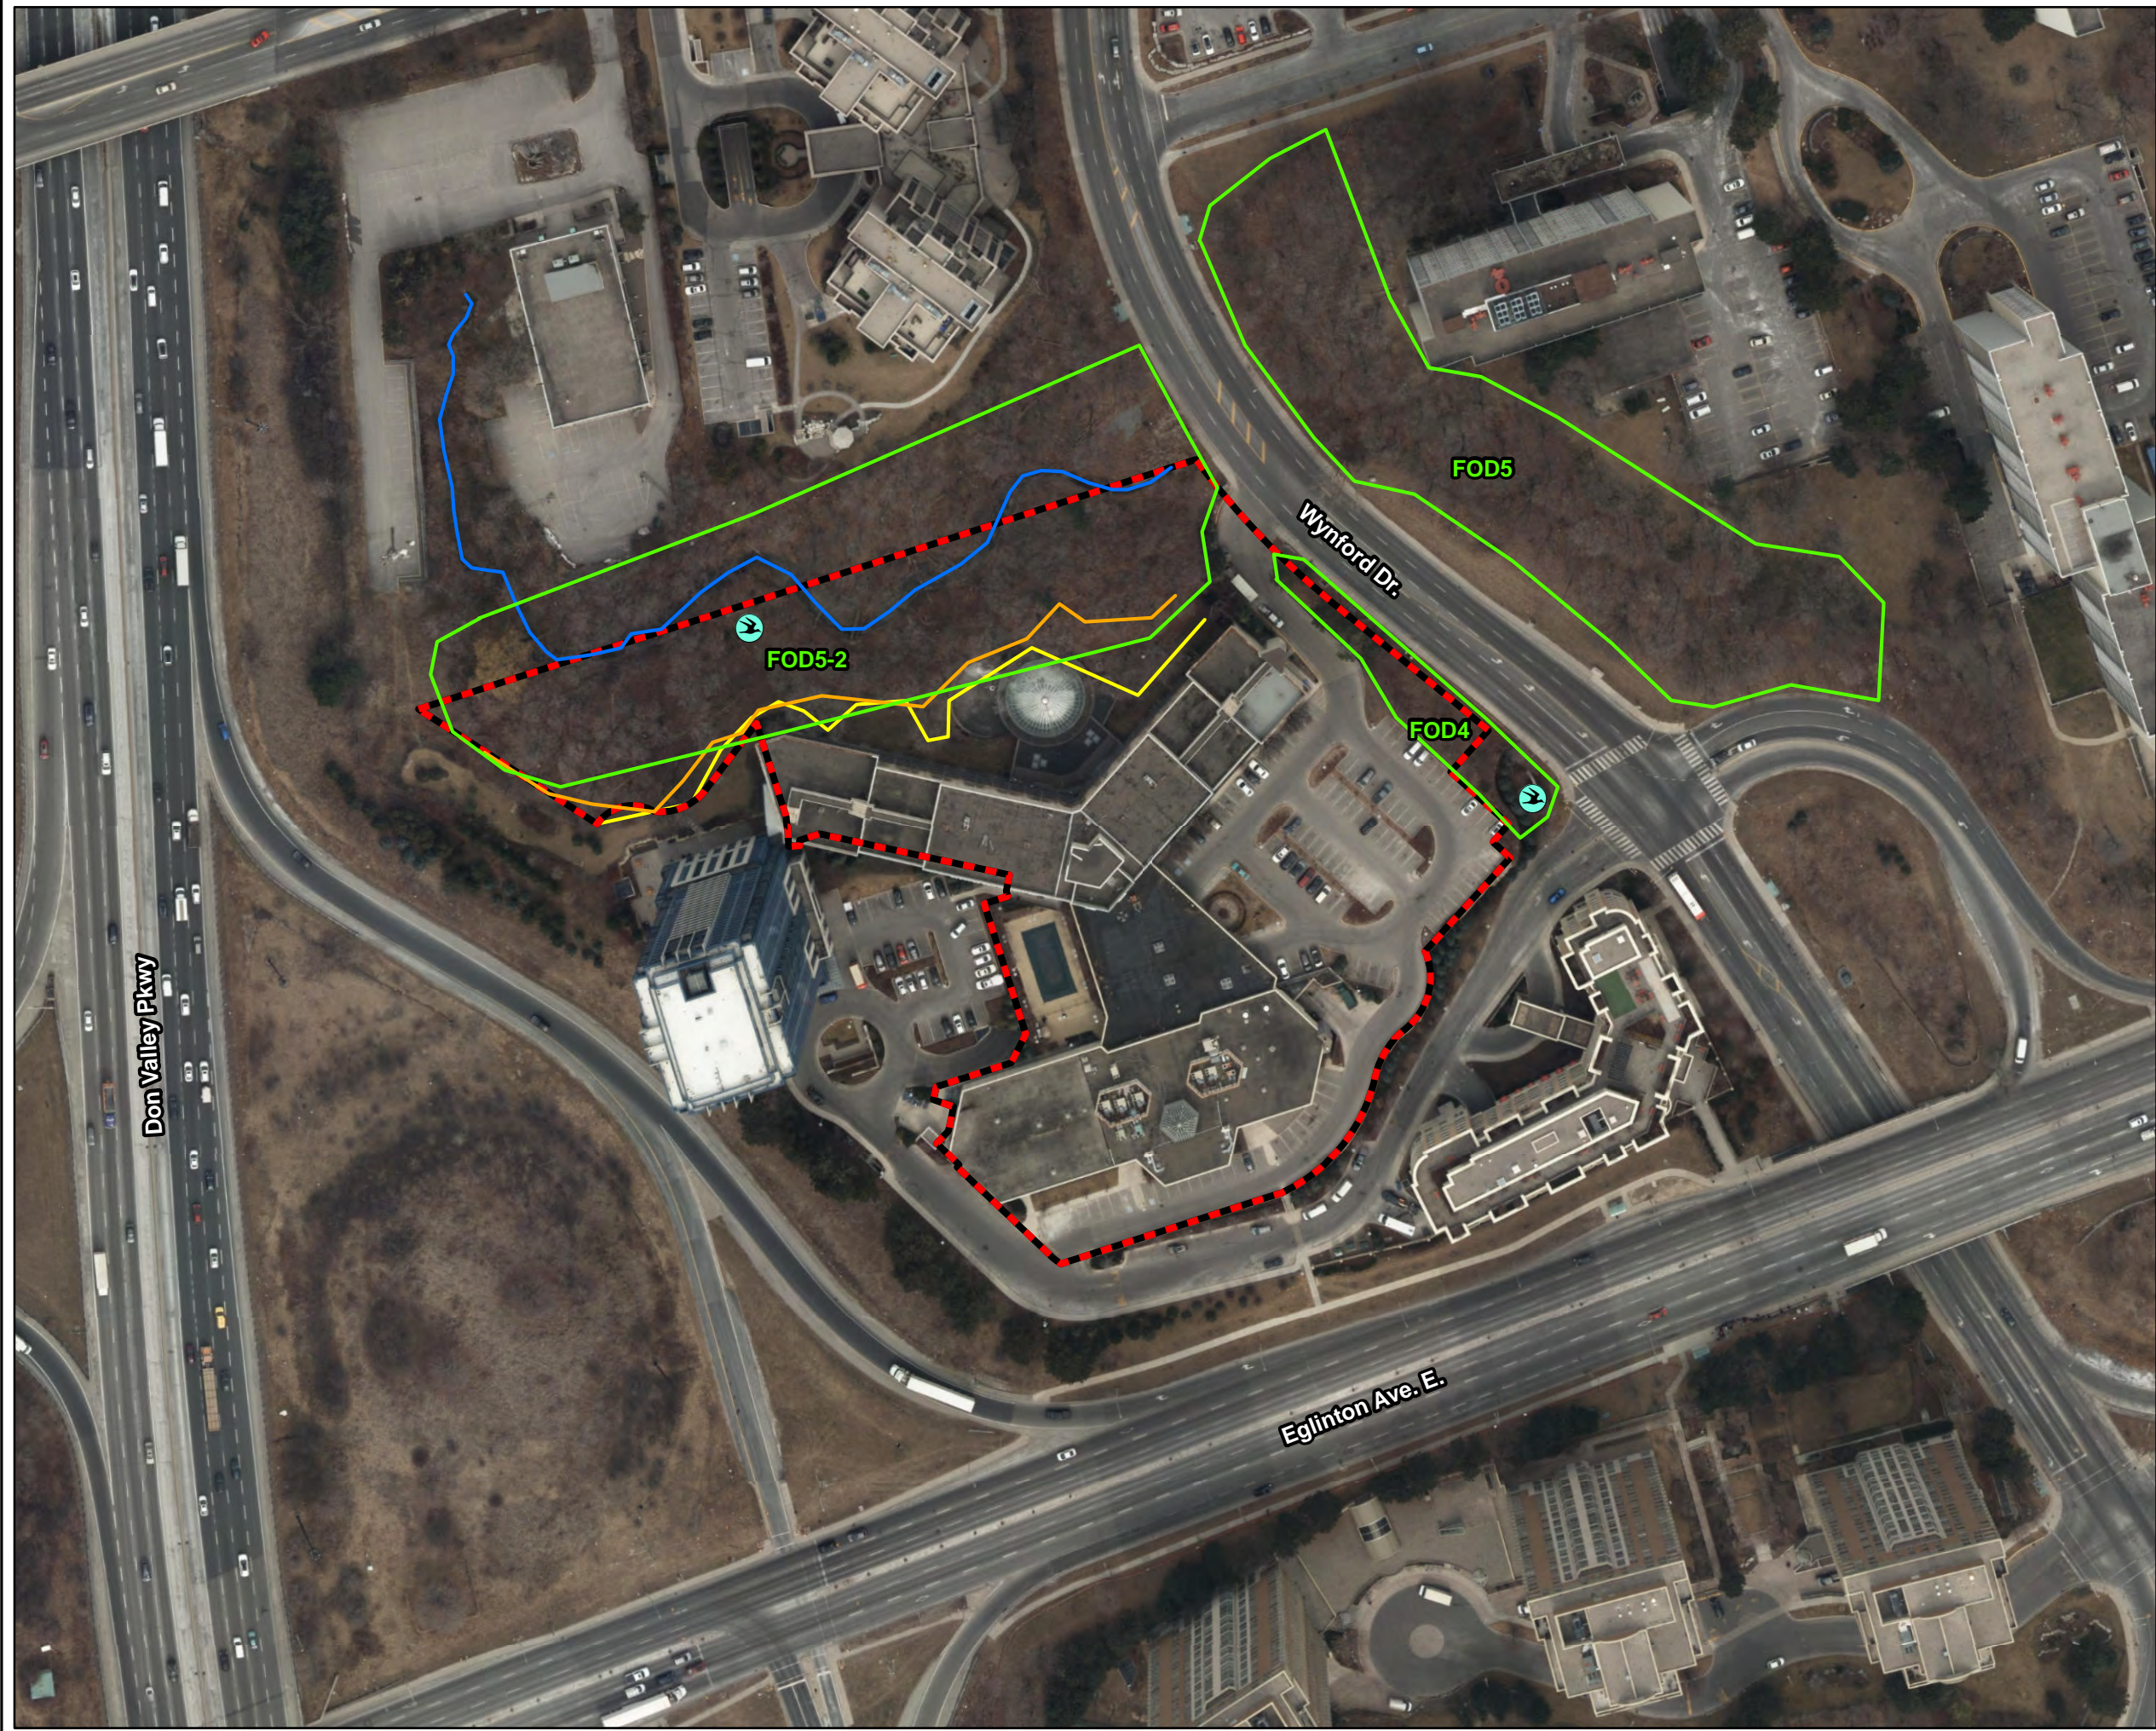
Project #	2019-187	Figure #  <b>2</b>
Date	August 2020	
Scale	1 : 1,500	
Prepared By: JJJ	Verified By: BDB

- Property Boundary
- Watercourse
- Vegetation Community Boundary
- Dripline
- Top-of-Bank
- Breeding Bird Point Count Location

175 Wynford Drive  
Toronto, ON  
*Existing Conditions*

The following section provides a description of the existing conditions within the study area. The vegetation and topographic features of the study area are shown on Figures 2 and 3, respectively. Site photographs are provided in Appendix A.

Two-point count stations were selected in representative habitats within the study area (Figure 2). The point counts followed the second Ontario Breeding Bird Atlas methodology (Cadman et al. 2007). All species and numbers of individuals were recorded during the survey. The surveys were conducted between 8:20 am and 9:20 am on June 12<sup>th</sup>, 2020.

Two 10-minute stationary point counts were completed during the survey. Due to the noise disruption from the traffic on the Don Valley Parkway, the usual 5-minute point counts were doubled to try and census any species that may have been missed with the high level of noise from vehicles. Temperature during the survey ranged from 14 to 16 Celsius, with wind speed in the 10 to 15 km/hr. range, and mostly clear skies. The location of the point counts is shown on Figure 2.

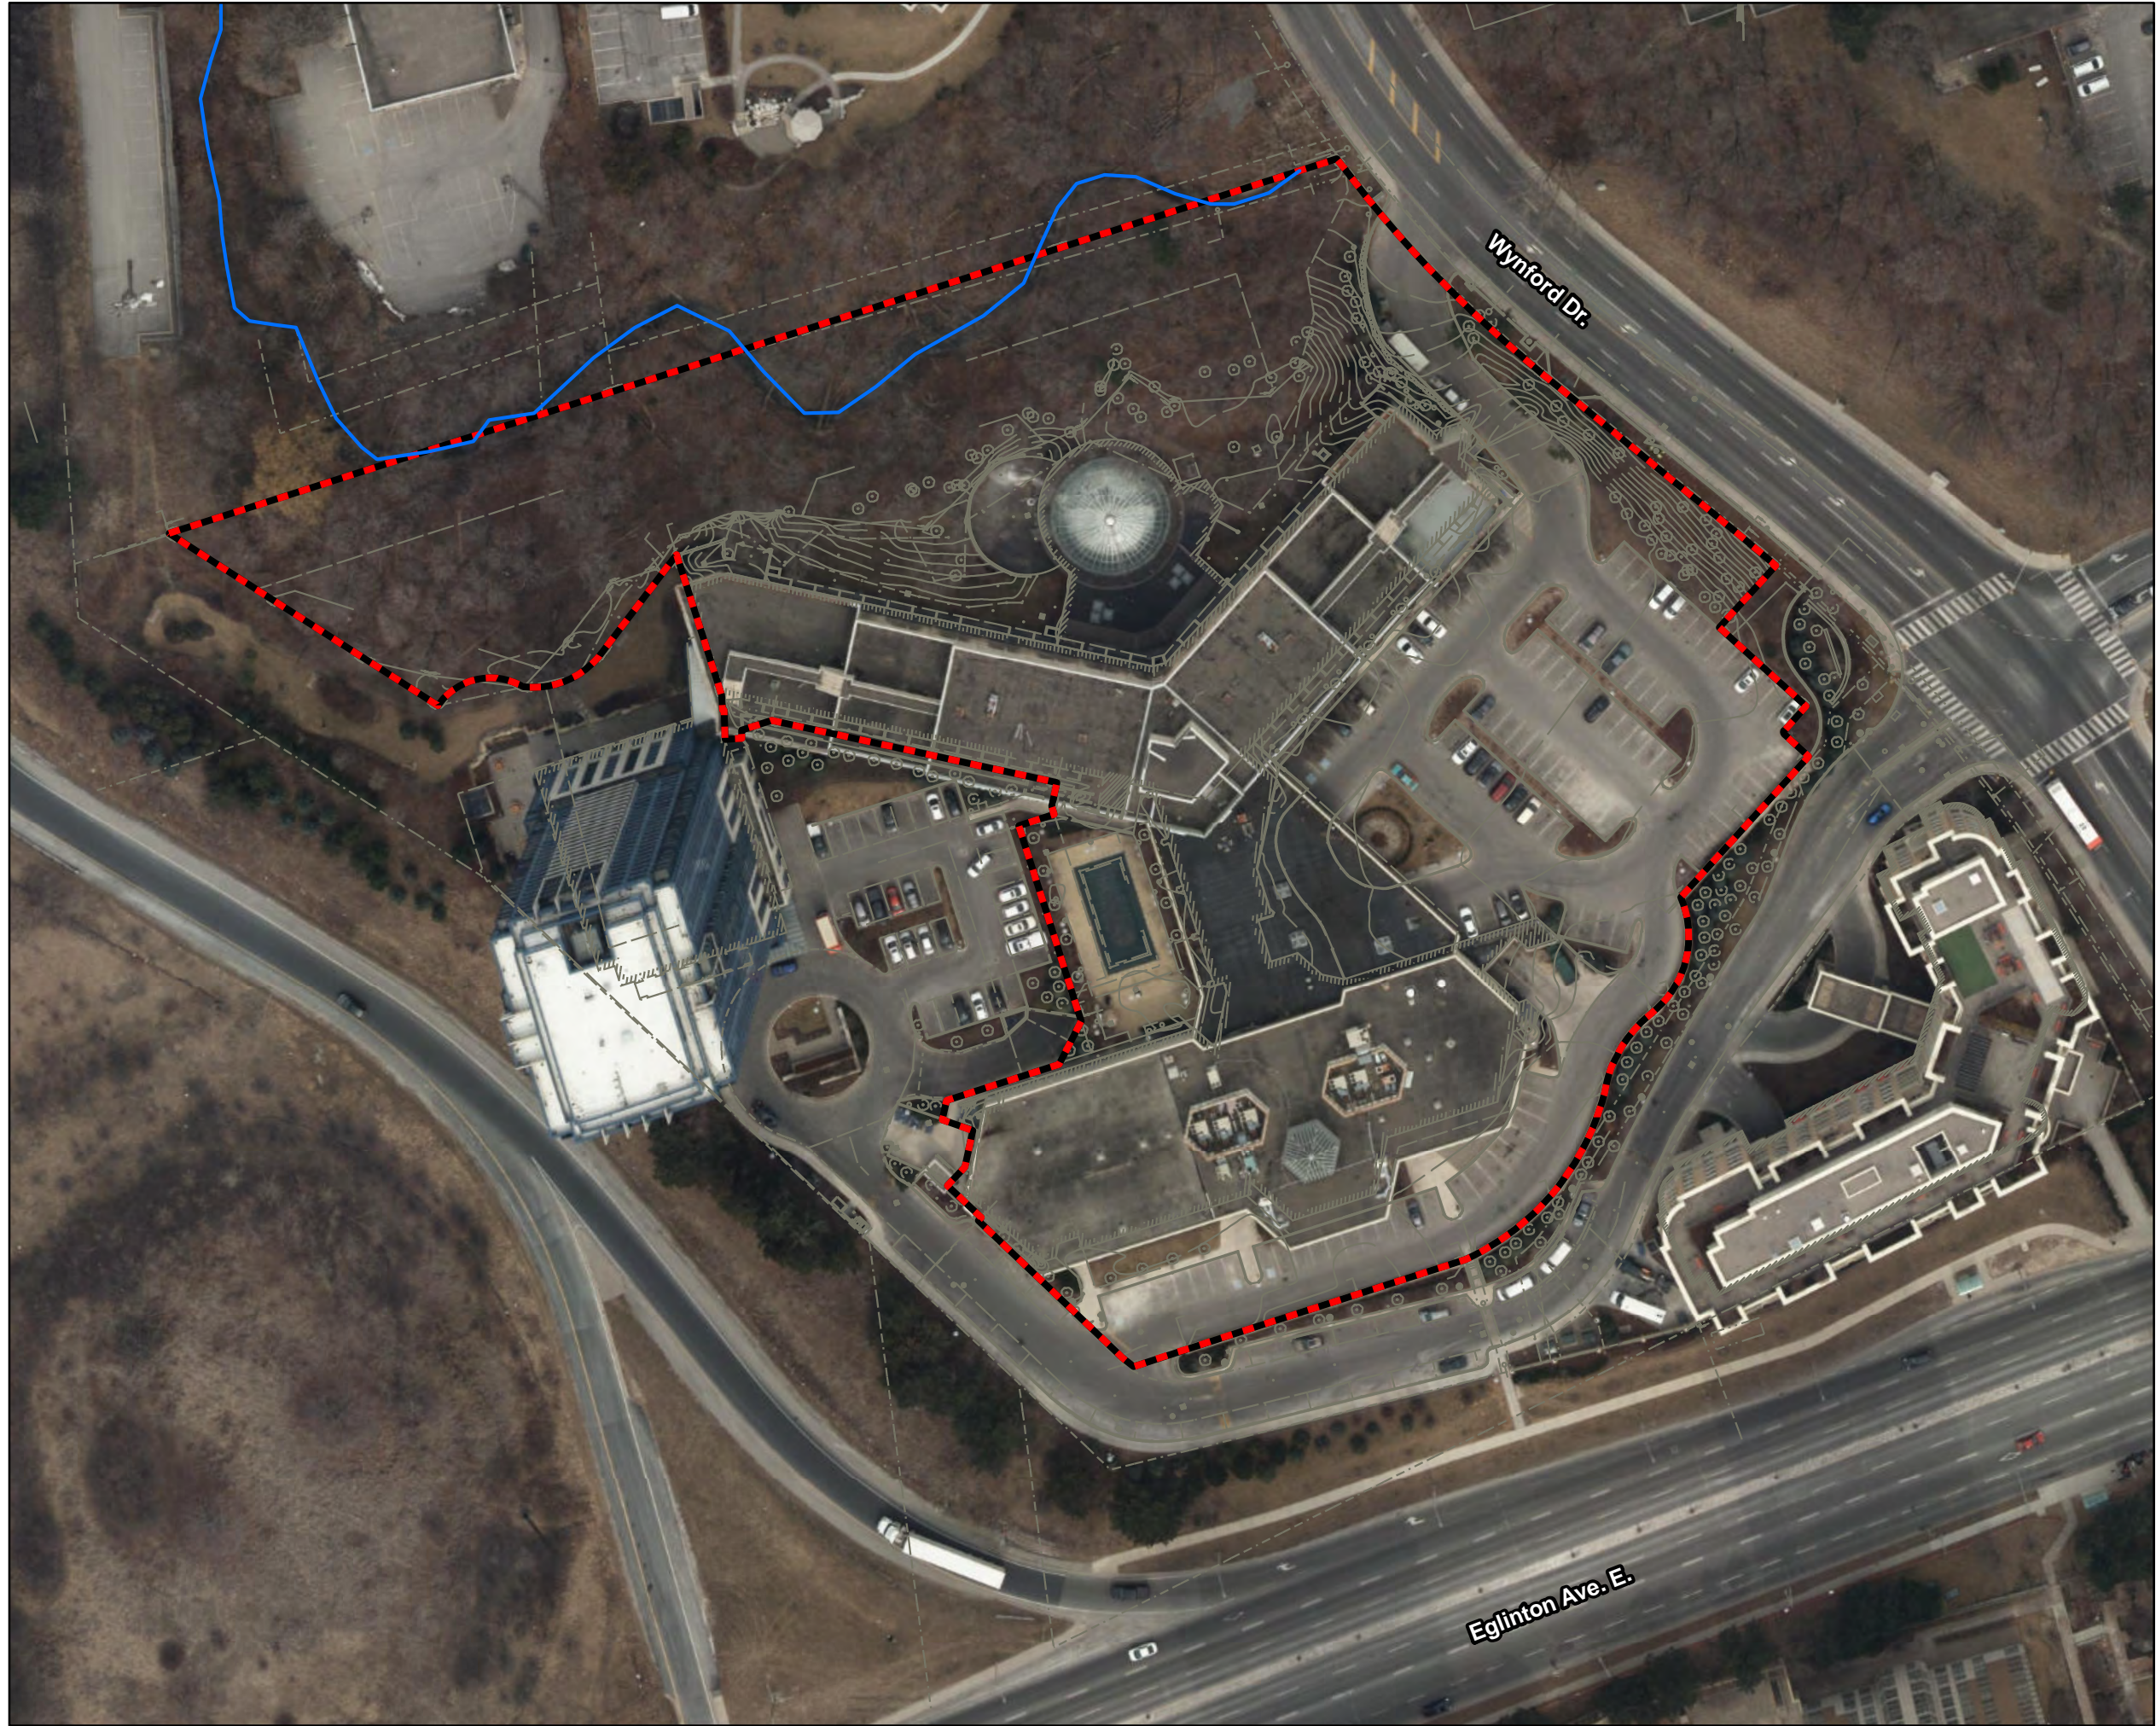
Project #	2019-187	Figure #  <b>3</b>
Date	August 2020	
Scale	1 : 1,000	
Prepared By: JJJ	Verified By: BDB

175 Wynford Drive  
Toronto, ON  
*Topography*

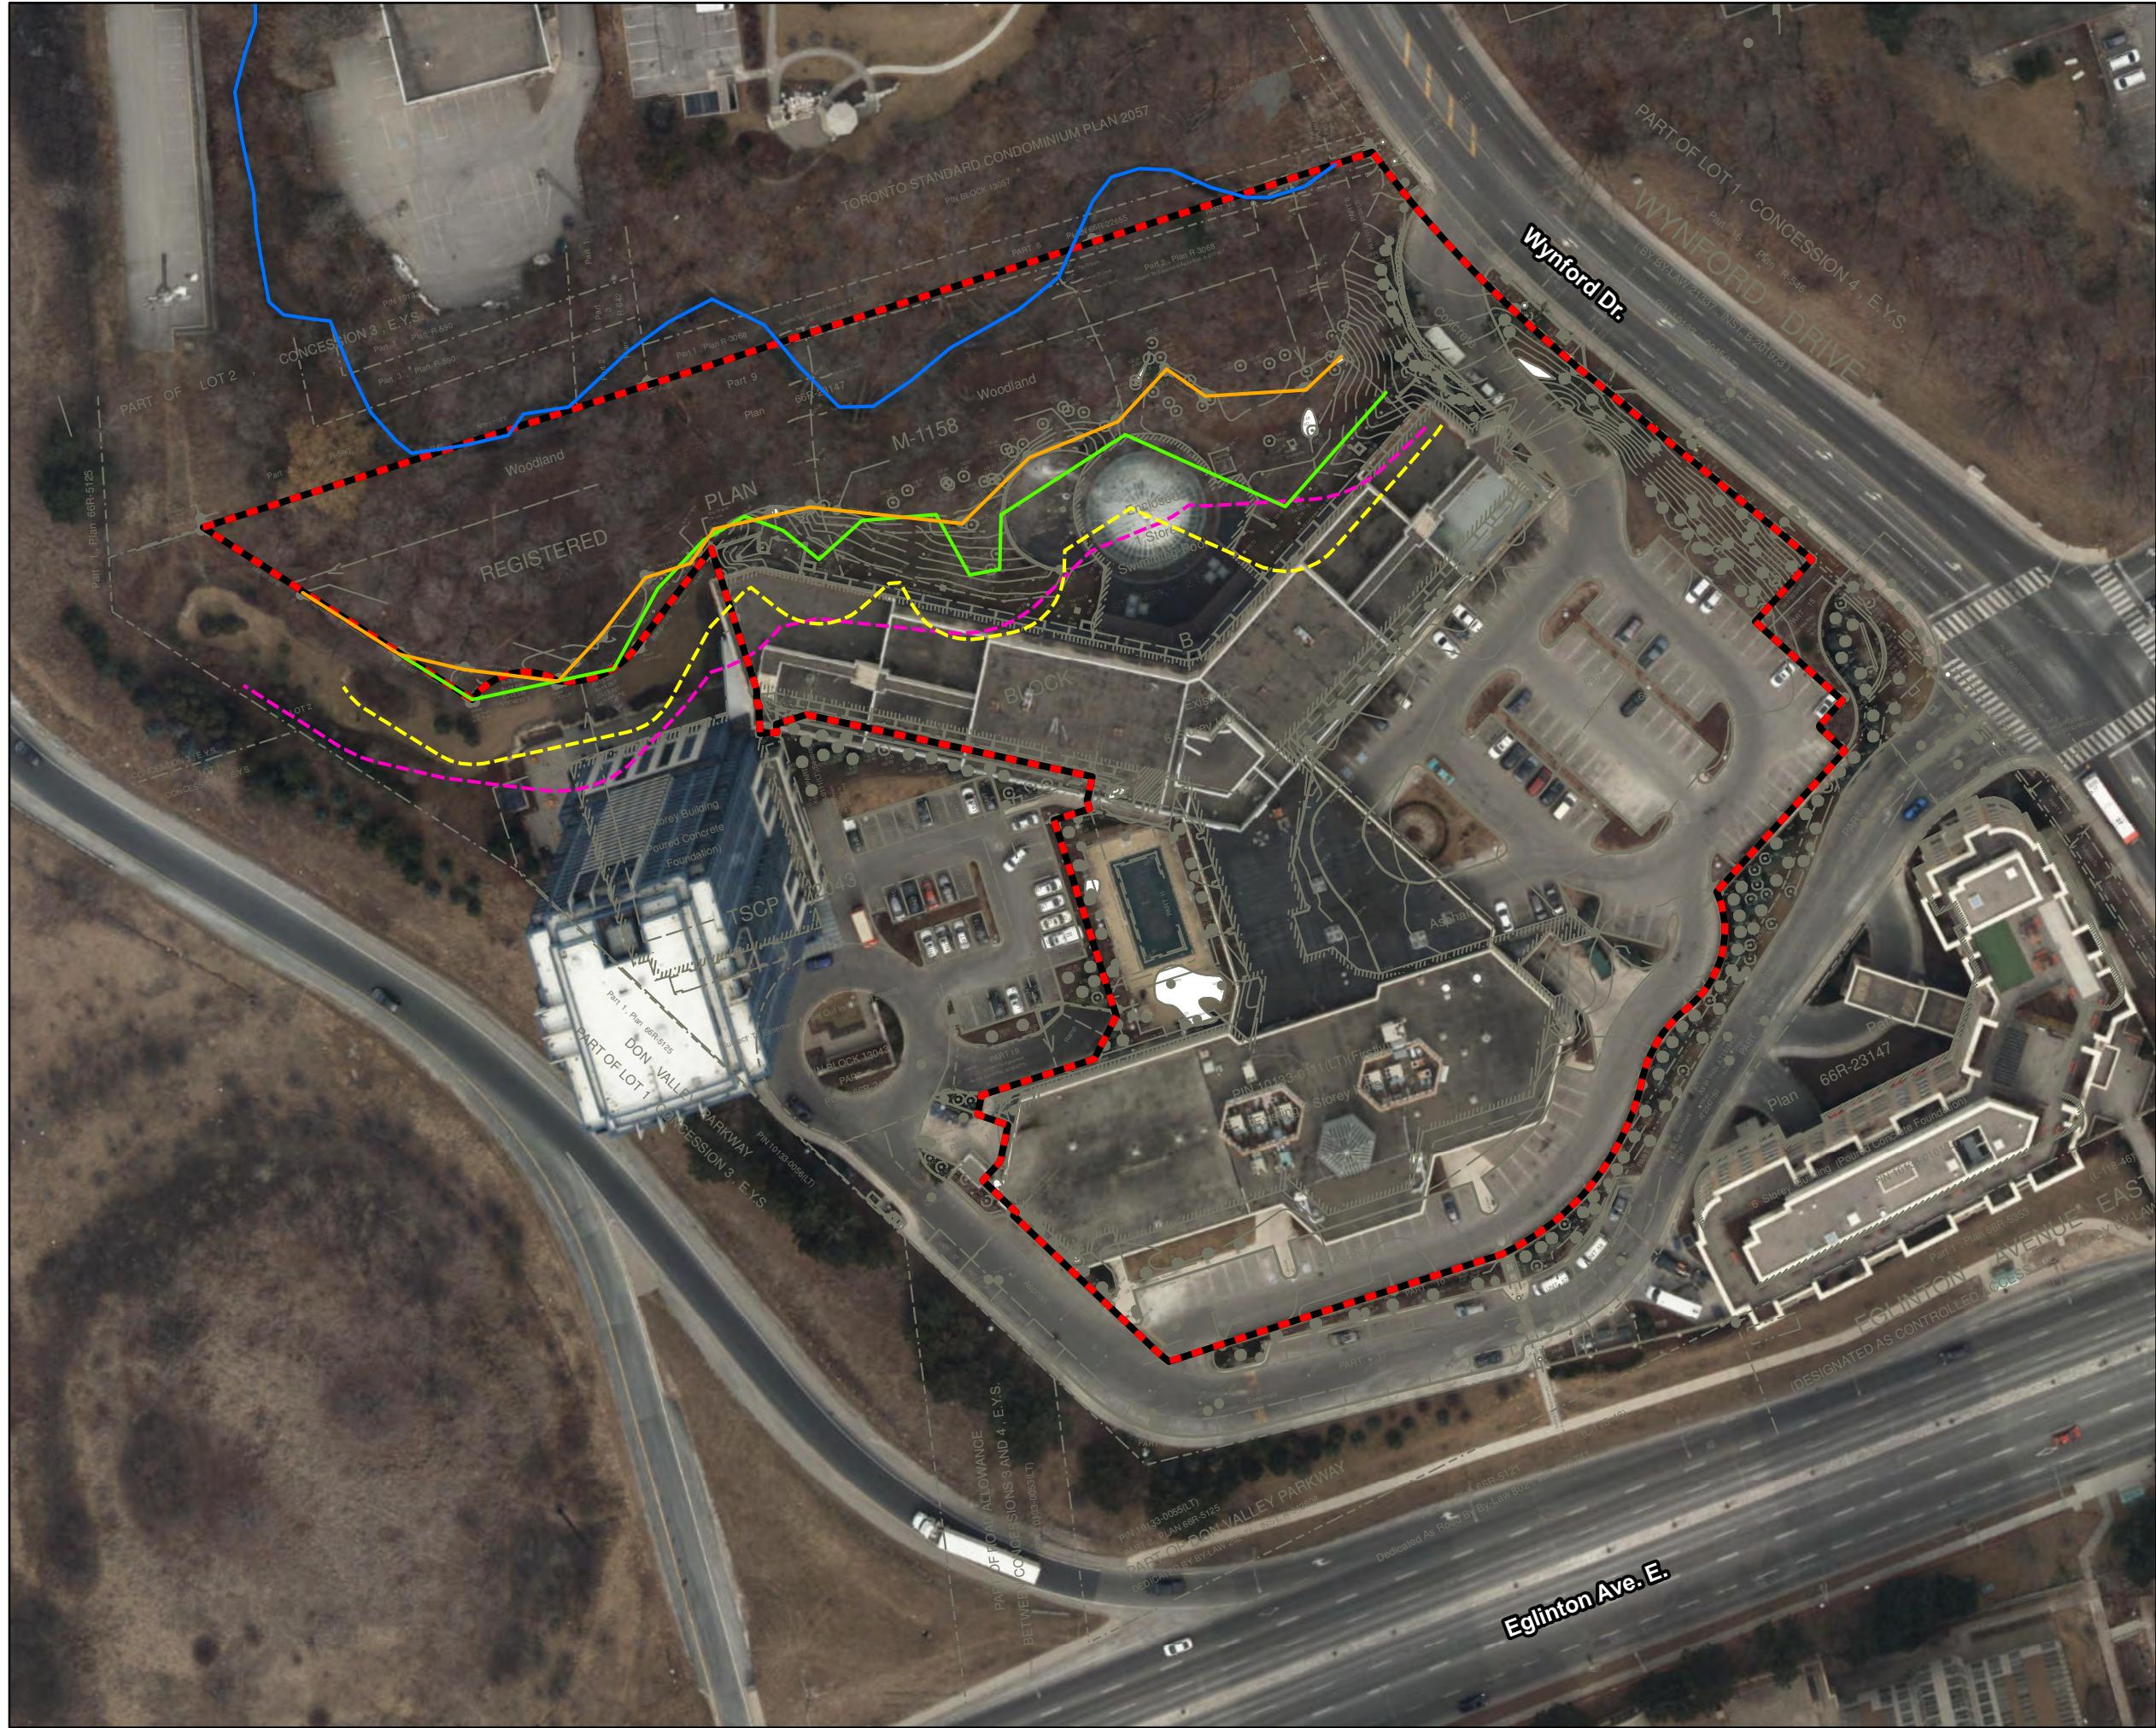
- Property Boundary
- Watercourse
- Dripline
- Top-of-Bank
- 17 m Top-of-Bank Setback
- 10 m Dripline Setback

The limits of the City of Toronto NHS are shown on Figure 4. The boundary generally coincides with the edge (dripline) of intact natural plant communities associated with the East Don River tributary ravine.

The limits of development on the subject property are shown on Figure 4. The limits incorporate the City of Toronto NHS (dripline plus 10 m) plus the long term stable top of bank (LTSTB) and a 10 m buffer (refer to *Slope Stability and Erosion Risk Report* – Grounded Engineering Inc. 2020 for details on the slope analysis). The long-term stable slope crest ranges from 3.7 m to 7.4 m from the TRCA staked top of bank.

The limits of development, as shown on Figure 4 and Appendix A, are based on the results of a *Slope Stability and Erosion Risk Report* conducted by Grounded Engineering Inc. (2020). The long-term stable top of bank (LTSTB) line plus a 10 m buffer was identified as the “limits of development” for the subject parcel of land. A 10 m buffer has been provided from the dripline of the edge of the ravine. The setback requirements are based on City of Toronto and TRCA policies.
