SLOPE STABILITY AND EROSION RISK REPORT

175 Wynford Drive
Toronto, Ontario

Grounded Engineering Inc.

File No. 20-153

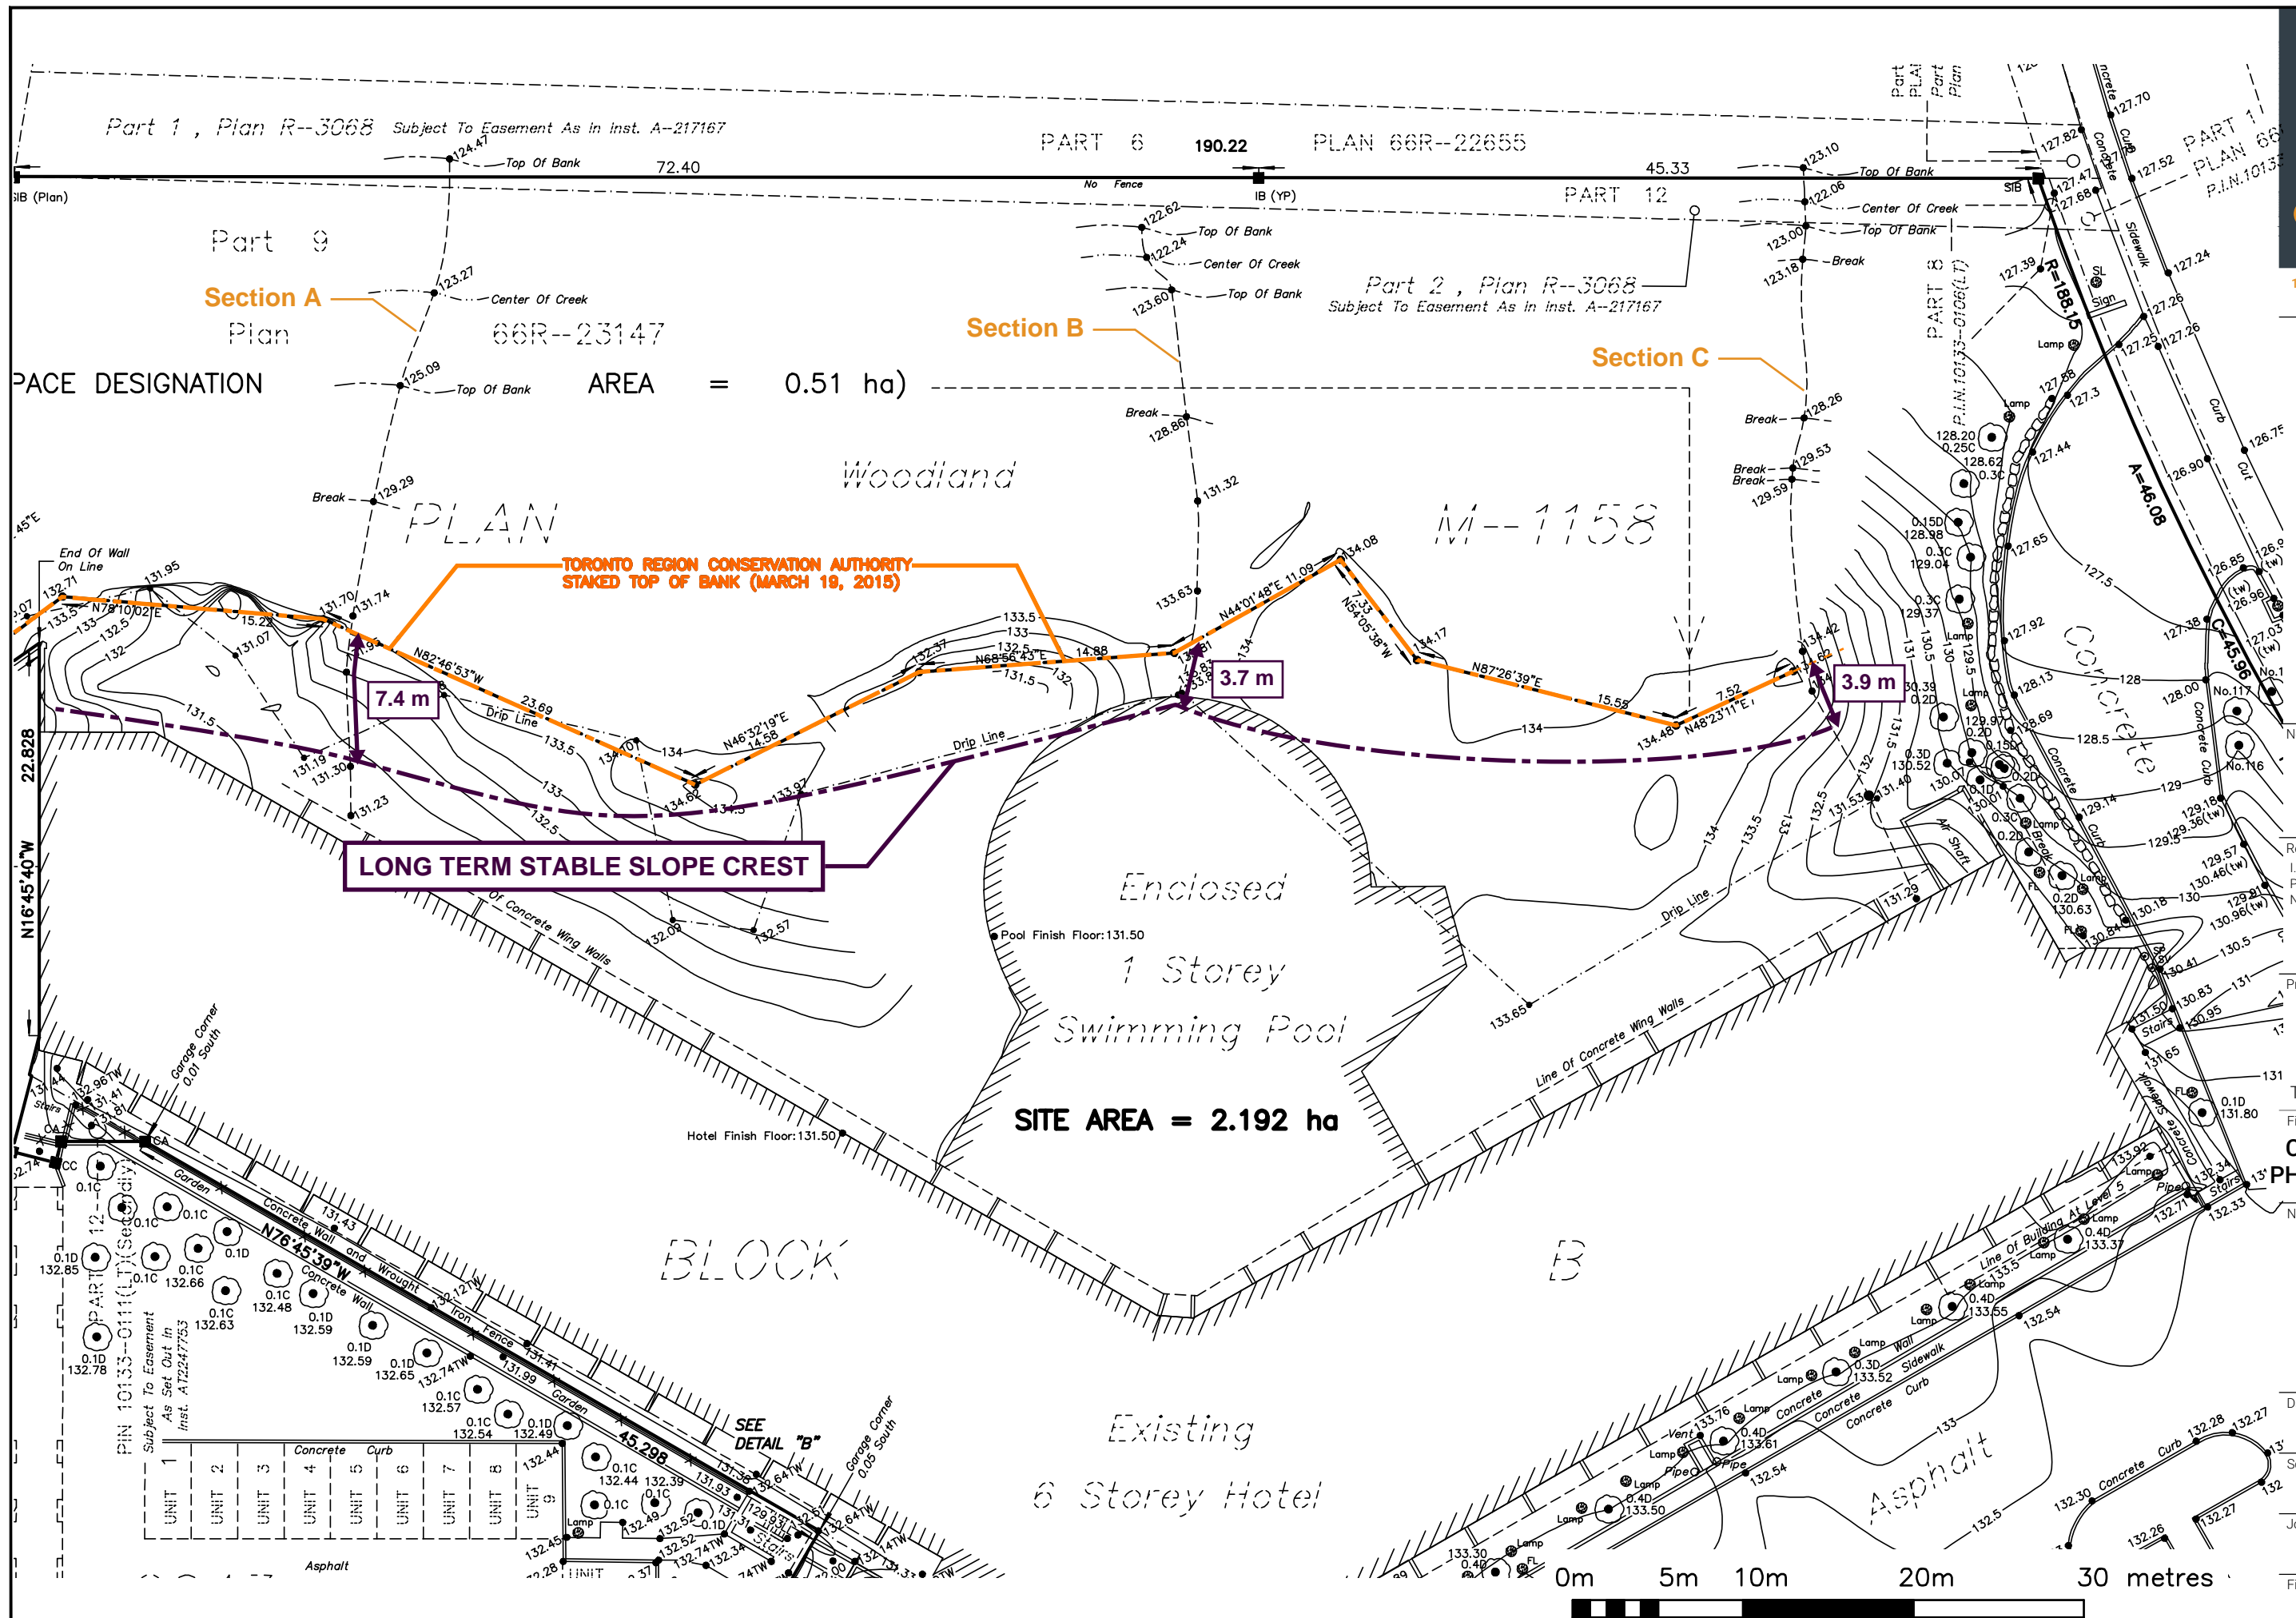
FIGURE 5

The LTSSC position is outlined in plan on Figure 5, where the toe erosion allowance (7 m) and stable slope inclinations in section intersects the tableland. The LTSSC was determined using a minimum factor of safety of 1.5 under normal ground water conditions and 1.3 for temporary elevated ground water conditions.

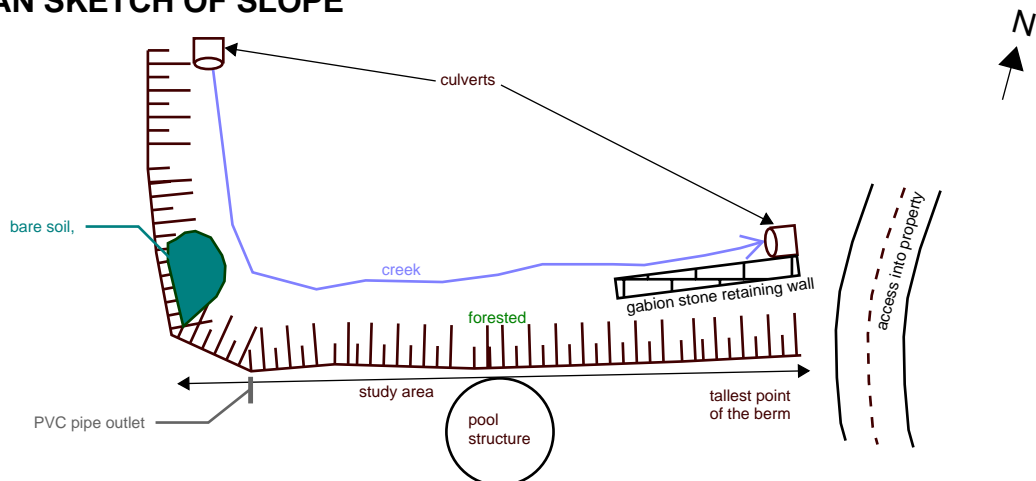
13. PLAN SKETCH OF SLOPE

No slide features were observed at the toe of slope.
